Boilers can Fail

This document was written by Vernon Lidstone and was published in the Southern Federation newsletter in June 2007.

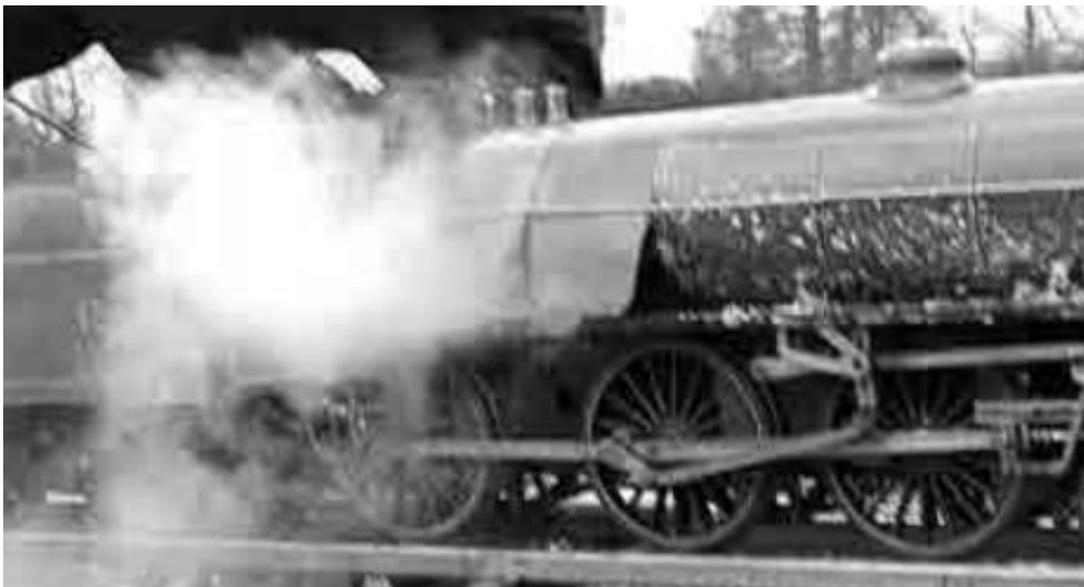
On Saturday, March 25th 2007 the Pike House Railway Steam Day was well under way with some twenty enthusiastic visitors, their grandchildren and some excellent visiting locos. Penny's cottage pie had gone down a treat and I was building up steam on my 5" gauge B1 'Mayflower'. The water gauge was showing around 'half a glass', the pressure was approaching 80 psi - working level - and the safety valves beginning to blow. We were just getting ready to put the engine on the track when a large cloud of steam blew out of the right hand side of the boiler. It blew the cleading out which fortunately deflected the steam downward. (See photo below). Recovering from the surprise I opened the blow-down valve and dropped the fire.

The boiler was removed from the chassis, photographed and taken to Trevor Tremblen, of Swindon Boilers, who examined it. Later the same day two CSME boiler inspectors came and also examined the boiler. They all arrived at the same conclusion that "the silver solder had failed to penetrate the firebox stays". The firebox stays were measured and were 1/8" diameter, in accordance with the drawing, had rivet heads inside the firebox and were at 3/4" centres. Trevor also spotted that the crown of the firebox

had come down about 1/4". You can see from the photo above that a dozen or so firebox stays have pulled out. It has been pointed out that crown stay arrangement is not according to Martin Evan's drawings, which shows a girder stay rather than rod stays. Trevor Tremblen also said that there would be many more crown stays when building a B1 boiler today. All the correct procedures were followed and it is hard to know what could have been done differently, thankfully the boiler failed relatively safely, it did not split

and the cleading deflected the steam effectively, so that fortunately no one was hurt. People have been very supportive despite this serious failure and Swindon Boilers have kindly agreed to build me a new boiler very soon. Many thanks to all involved. Remember, when you are building your next boiler, do pickle your stays and ensure there is enough space for the silver solder to penetrate thoroughly!
