## Britannia Return Crank Repair

This document was written by Jon Mottershaw and was originally published by The Colchester Society of Model and Experimental Engineers in November 2013

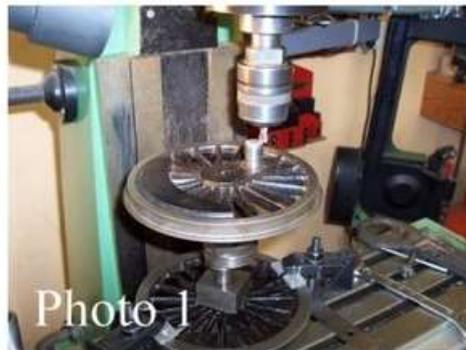
Figure 1. Crank Pin Modification

It was becoming evident that the seat carrying the return crank on one side of my Britannia was showing signs of distress. The taper pin securing the return crank to the crank pin kept working loose, allowing the return crank arm to “fidget” on the crank pin. This was undoubtedly affecting the performance of the valve gear and would inevitably lead to complete failure of the fixing. This was no doubt due to the number of times that the return crank had been re-positioned and fresh holes drilled through the seat to take the taper pin. During its thirty years life the locomotive had been in the hands of a number of previous owners who may also have made modifications.

The driving axle was removed from the locomotive for the repair, which it became obvious, would have to be completed with the wheels still on the axle. Grub screws in the form of French keys secured the axle and crank pins to the wheels and they could not be moved. Dismissing, therefore, any thought that the crank pin should be pressed out of the driving wheel and replaced with a new one, a journey to the Frinton Locomotive Works (members workshop!) was made where an alternative solution was designed. It was decided that the damaged return crank seating should be removed and a new seating screwed into the end of the crank pin as shown in figure 1.
