## Mabel a 7 1/4inch Wren Engine

This document was written by Rob Hitchcock and was originally published by Plymouth Miniature Steam and republished by the FMES in the July 2023 Newsletter

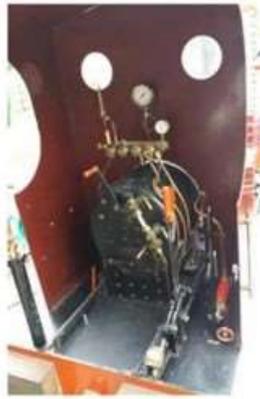
The wheels were several millimetres under the design diameter which although shows some wear would be serviceable but need some attention in the future. It appeared as though the engine has had a mixture of inexpert maintenance together with some good work which had not been finished, for example the boiler is held up by copper brackets on the boiler and should rest on manufactured metal spacers to level the boiler rather than two pieces of firewood wedged in.

The capable looking boiler hand pump was seized up and much of the pipework needs attention, I also discovered much later that the safety valves were in danger of blowing out due to slackness in the threads, curiously the threaded holes were correct in size, but the valve body threads look as though they had been manufactured more than .020" undersize. I have a scheme to remedy this but have not yet done it, more later. I think you can now imagine the type and scope of the repairs to be done and I am aware I took a calculated risk in not tackling the boiler issues first rather than working on the tender, this was because if the boiler would not come up to scratch there was no way in which the engine would be a runner in 2023 anyway and without the tender, I could not run the engine on the track.

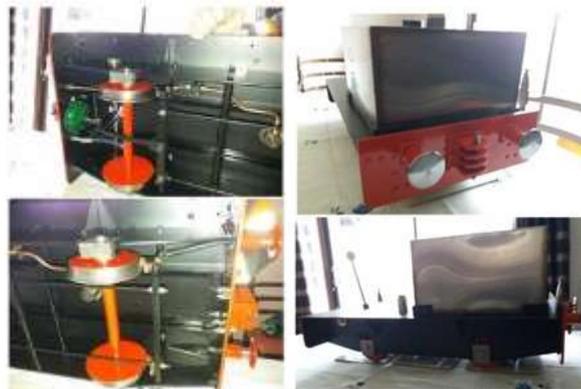
The tender also took quite a lot of refurbishment. When examined closely each buffer beam was only held on by four 2BA bolts in shear. I had to reinforce the suspension, buffer beams and frames, also replace and increase all the brass 2BA bolts and nuts with steel, make four new couplings and two new spring buffers, also repaint and provide a new seat. Most of this is now complete apart from the painting of the plating and the seat. One of the most interesting tasks was the couplings, I had already decided that as this engine had been commercially built there were several items that did not strictly conform to the original design intent which in this case would have required a fabricated hook and chain restraint, I decided not to be too pedantic and make a nonstandard pin type drawbar capable of adapting to varying height stock, this was made from 6mm plate and designed to be interlocking from laser cut parts, it is remarkable how well and precisely laser cut parts fit without much fettling. The parts were all tig welded and retained by six 6mm bolts providing a very strong attachment. For the buffer heads I used a similar technique and rather than turn down 3" diameter bar, used laser cut discs welded to the buffer piston. I mentioned earlier that the tender did not appear to have an internal tank, I had assumed that at some time it had one but it is possible that it held water without, indicated by an excess of rusty bits. If it was designed to have no internal tank it must have been a very leaky one. I decided to fabricate a new 1.5mm thick stainless internal tank, which will sit on a new 2mm thick laser cut deck, the tank has a bottom outlet and a filler neck under the seat. This has been completed and seems to be about 15

litres capacity. while I was making the bottom outlet, I incorporated a mesh strainer which can be pulled out through the top filler for cleaning.
