Locomotive slide bars and problems

This document was written by Mike Wheelwright and was originally published by Worthing and District SME in their newsletter in the Autumn of 2009

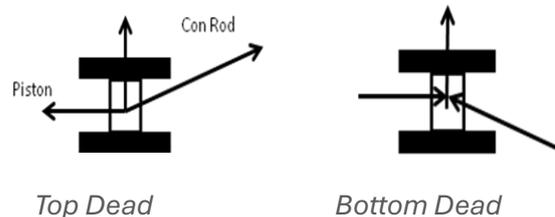
Consider an engine moving forwards: when the crankpin is on TDC the connecting rod is in tension and it pulls the crosshead up against the top slidebar, then at BDC the connecting rod is in compression and again it pushes the crosshead up against the top slidebar. It looks like only a top slidebar is required for a locomotive that never reverses.

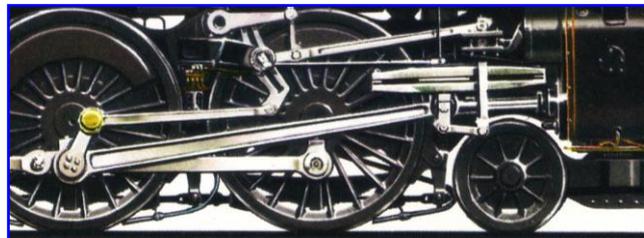
I have taken advantage of this situation on models by using mild steel for the lower slidebar and reserving gauge plate for the upper one that takes the force pulling a train (sounds like LNWR penny pinching!) Most designers used two identical slidebars with symmetrical crossheads on outside cylinder engines but a frequently used alternative was the Laird 3-bar arrangement in which the top bar is conventional but the bottom bar is replaced by two narrow bars bolted to, and separated by spacers from, the underside of the upper bar. This is arranged above the piston rod so that an asymmetrical crosshead with a "T" shape passing through the slot between the lower bars carries the slipper running between upper and lower bars. As usual in engineering there are trade-offs, the Laird design uses a smaller crosshead thereby reducing reciprocating mass but has forces unequally distributed about the centreline.
