“Old Rube restoration part 13”

This document was written by Paul Naylor in winter 2025 and is the eighth article in a restoration project. The articles were published more or less simultaneously in the Frimley and Ascot Locomotive Society newsletter.

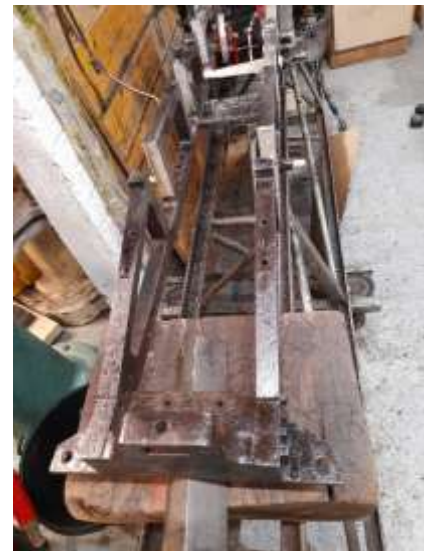
I divided the chassis into two bits (figuratively speaking!), each side of the driving axle. The back end was dry, the paint poor and the metal was rusty where it showed. This is the bit that got no oil soaking or, if it did, it was rapidly dried by the ashpan and fire. I scraped the paint off this and used a wire brush to make sure followed by a wash down in acetone thinners to get rid of last traces of oil in joints etc. I am a fairly recent convert (pardon the forthcoming pun) to Jenolite rust converter. I used this a lot in repairing some steel on a car and I was impressed with the performance. I had some of this as an aerosol 'in stock' so, after masking the sliding surfaces in the frames for the axle boxes, gave this end of the chassis a spray with it as per the instructions. This is now going through its 48-hour curing period before I can apply paint (photo, right).

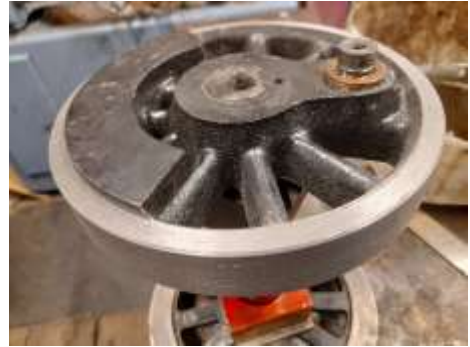
I turned the wheel to suit the tyre and with the slight push fit as planned for Loctite. This was like turning up the treads for the other wheels, however without a means of measuring accurately the diameter, I had to go slowly. The outside 3mm of the rim had to be turned away for the inner flange on the tyre, so that bit provided a test cut: I was able to approach the final size a 'thou' at a time using this 3mm of tread, and when the fit was OK, I cut away the whole width of the tread, again in stages and with light final cuts. When I had done this, I trimmed back the 3mm on the wheel rim for the tyre inner flange. The photo shows the wheel ready to accept the tyre.

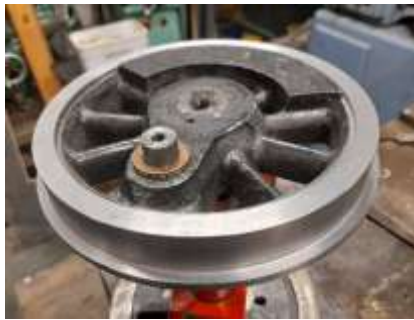
After roughening the tyre mating surface with a bit of coarse

grit emery, I cleaned everything with meths and applied a good coating of Loctite 603 to the tyre inner surfaces. The moment of truth then arrived, and I was able to push the tyre into place with the aid of a hammer and block of wood - I did not need to force it particularly – and then set it aside to cure. This is a piece I will sneak into the house for a bit of warmth! The photo shows the tyre fitted and undergoing curing but not yet machined outside to suit the other wheels. I looked up the curing time for Loctite 603 - I always had 24 hours in my mind – and indeed this is the time at 22 degrees C, but could
