## LMS 8F Overhaul

This document was written by Geoff King and was originally published by The Colchester Society of Model and Experimental Engineers in July 2008

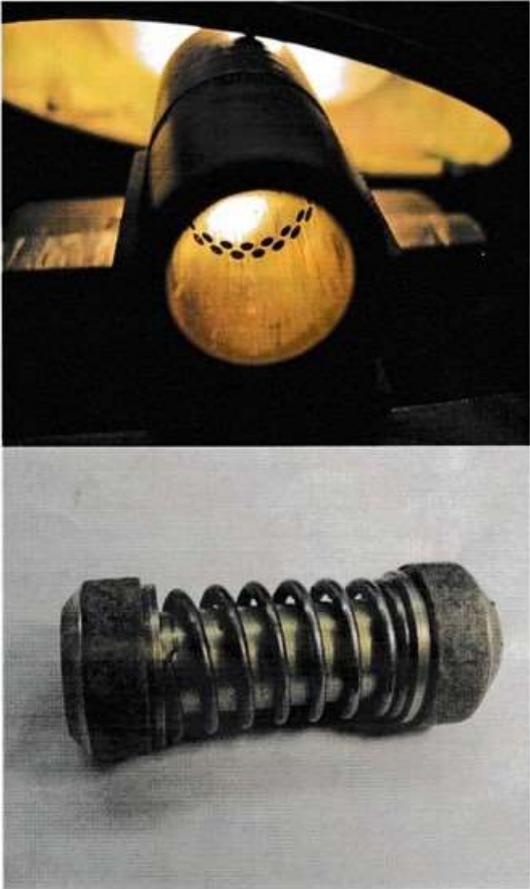
After tidying up a little of the scoring caused by the rust in the old sleeves the piston valves have been put back into use. It was thought that the piston valve PTFE parts would be "self-healing" and re-bed to a steam tight fit in the new bores. The pictures show the new valve sleeves and the old piston valves before they were refitted into the cylinders.
