Metallurgy or Manufacture?

This document was written by David Goyder as Editor and was published in the Southern Federation newsletter in September 2019.

Something for metallurgists and model engineers to ponder

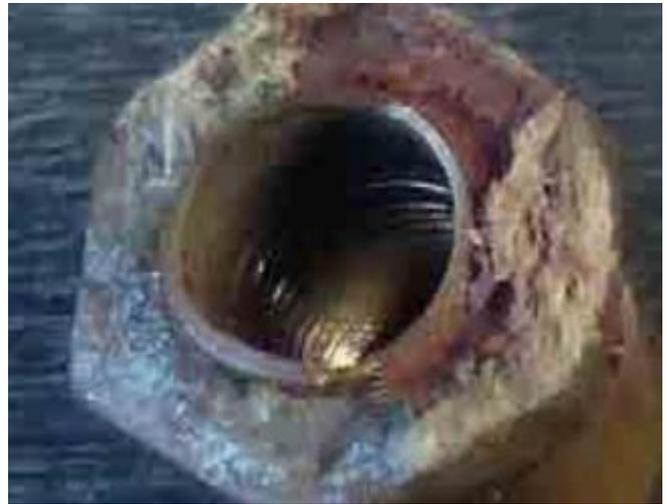
pliers in the hole and turning, all very easy really. Now we come to the analysis that I trust our readers will do. The top picture is the outer bit that was against the backhead and the lower picture is what was left. The shiny section seems to be all that was holding them together and that is after a shell test on the boiler at 180psi. By the shiny bit, I mean the less than half a circle on the right-hand side in the upper picture and a similar shiny rim on the portion in the lower picture, that was the part screwed into the backhead.

Here we have two little items that are actually one or should we say, were one until they rent themselves asunder (broke is too weak here). They are small and seemingly insignificant but we will continue. Some of you may know that your editor is bravely encouraging an old lady who has not steamed for some 50 years to have another go. She is a 3½in. Princess Royal built to the Clarkson drawings at least 50 years ago but by whom we do not know. This little item is a blow down valve mounted on the backhead. It consists of the screw put in the end and a hole, which you can see, underneath. As fitted, blowing down means the cab is filled with hot water and perhaps a little steam. So, could we improve it? Upon removal, it came away in two bits! The outer section dropped into the cab, the inner was extracted by putting the long nose
