## “Old Rube restoration, part 4”

This document was written by Paul Naylor in early 2025 and is the forth article in a restoration project. The articles were published more or less simultaneously in the Frimley and Ascot Locomotive Society newsletter.

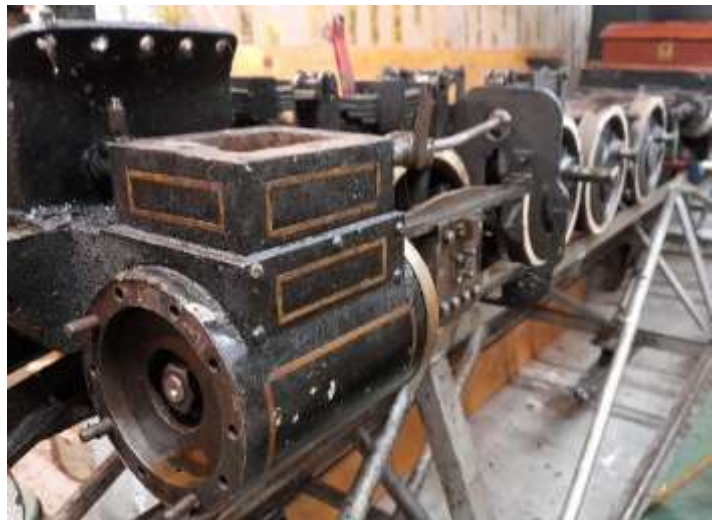
Whilst the whole chassis is liberally coated with steam oil (and as a result has no rust or other issues), steam oil – especially the viscous grade – turns to treacle when it is cold, and when it is cold *and* old it is even stickier, stops every thing from moving freely. As a result, this job was more involved than it appeared. I worked out that the Allen head countersunk bolts holding the pin end caps on were probably right-hand threads on this side, and so I approached the first with a suitable key and trepidation. This one was loose though and confirmed the righthandedness of the threads. The second was already rounded off and was stuck whilst the third (the connecting rod long one) was stuck but yielded to a slight application of the impact screwdriver. The fourth was behind the crosshead at the position of the crank that the chassis was at, and since the treacle had got a grip, I could not move the wheels. The rods and wheels however had some play, so the stickiness was the piston and slide bars. Assuming a major contributor was a stuck piston: not unlikely and since this was the most likely place to have some corrosion, I feared the worst: I removed the cylinder end cover. Fortunately, there was little evidence of rust and seizure so I had a few blows at it with some wood and a large hammer, but nothing moved. Plan B then: try to dissolve some of the treacle. WD40 is quite good for this sort of thing, but the amount needed was costly, so I used my stand by of a mixture of transmission oil (the red stuff) and thinners. Eventually, and after working it into the piston, the gland and the slide bars and crosshead, it moved! A bit more and it freed up well, so that allowed me to remove the connecting rod and then the fourth bolt which was quite easy. The piston rod is held onto the crosshead with, it seems, a riveted over pin so I don't really want to remove this and so I still don't know what the piston packing is...but it seems to be quite airtight. The rounded over second bolt succumbed to some propane heat and some urging. Let's say that I will need a new bolt here...

The rods on this side now repose in a box. This job took two full days.

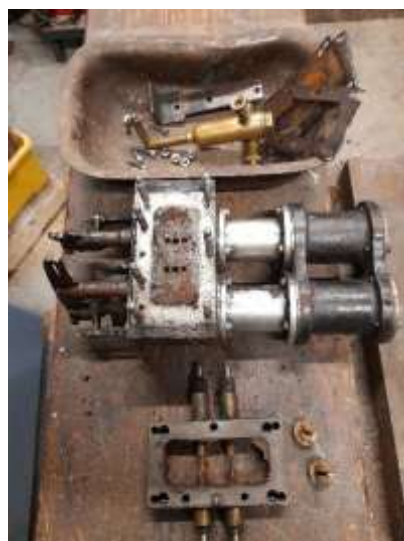
Taking the pump apart showed it is cast iron throughout, including cast iron piston rings in all four cylinders (two steam and two feed). Not the thing for water methinks, and the fact that that all four cylinders are the same bore, means that it is not going to be a water feed pump. I settled for an air pump... the give-away might be the check valves on the feed side, but these are missing!

Anyway, I took it apart, replaced the valve rods which were corroded with stainless steel ones, polished up the bores and replaced the graphited yarn gland packing with PTFE. Having never handled one of these, I was intrigued how it works. The slide valves on each cylinder are arranged so that they are moved quickly by the top and bottom few millimetres of the main stroke, and there is no lead on the valve. The valves operated by each cylinder switch steam to the opposite cylinder, so when one goes up, the other waits until the first gets to the top and then its valve operates allowing steam into the second cylinder which then moves until it reaches its bottom and sends the first one the other way. Got it?! This means that the steam ways in the block are a bit of spaghetti hidden in the cast iron, and indeed one was solid with treacle which had to be removed. It also means that it is not obvious to me what happens first and some other ramifications (see later). Bit like the chicken and the egg.

I put it back together (the steam side: I left the feed side off until I could see what was happening) and connected it up to my compressor. Yes, well, much air escaping, one or two fairly violent movements and not a lot else.

A lot of the air was coming from small holes at each end of the cylinders (drain holes obviously) and so I set to and made some small automatic drain cocks for these. I also tried to work out the valve settings logically, which gave me a headache. After much tinkering, I got it finally to go and stay going right down to around 20 psi. Still much escaping air though past the valves: I assume that this is a figment of the type as I cannot see how it can be avoided with no lead and the type of valve movement.

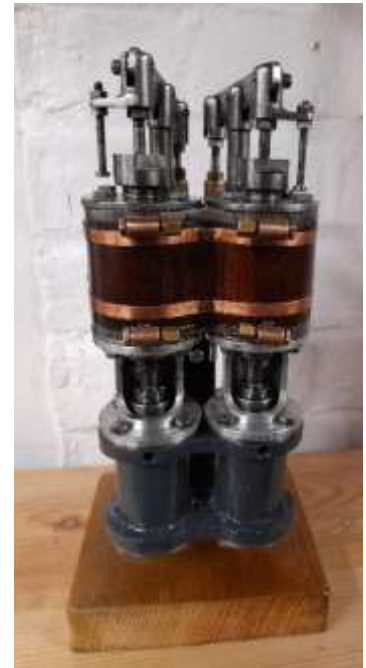
I mounted it for looks and convenience, and just maybe there it will stay...but it satisfies my need to have working things!
