“A Repair to Steel Boiler Tubes”

This document was written by Kevin Slater and was originally published by Bristol SMEE and republished by the FMES in the May 2025 Newsletter

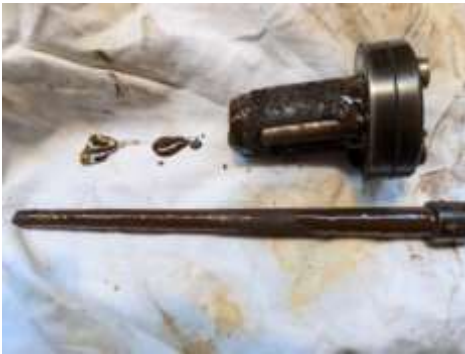
Small flap wheels were initially used to clean the rust/soot/grunge from the expander landing area at the end of each leaking tube. This was only marginally successful, and the rolling action of the expander cracked away and crushed more 'grunge'. This meant having to repeatedly clean the expanding tool.

repeatedly clean the expanding tool.

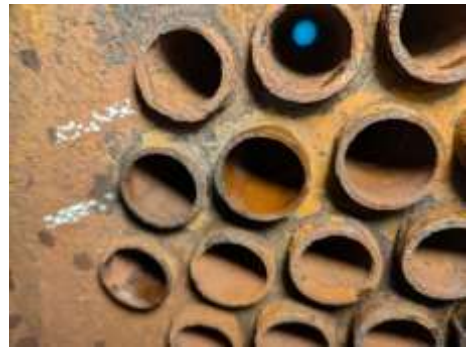
Despite the laborious process, Kevin successfully re-expanded the tubes and proved it by conducting a hydraulic pressure test to 500 p.s.i. on the boiler

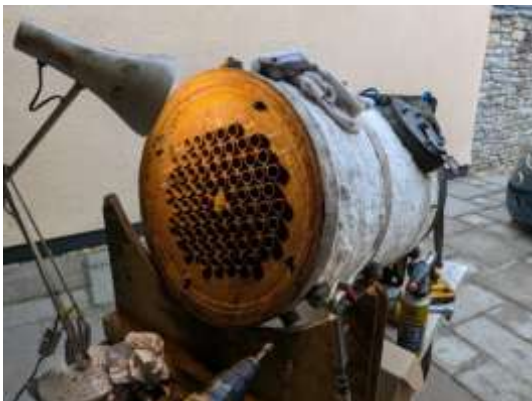
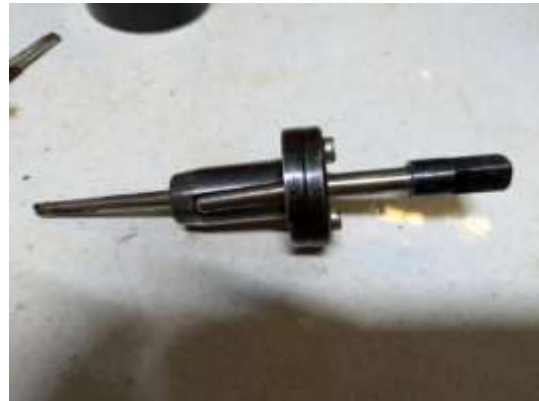
The quality of Wickstead's expanders was proven as they remained undamaged.

Replacing the tubes with new ones would have been a much more expensive alternative.
