## “Old Rube restoration part 5”

This document was written by Paul Naylor in early 2025 and is the fifth article in a restoration project. The articles were published more or less simultaneously in the Frimley and Ascot Locomotive Society newsletter.

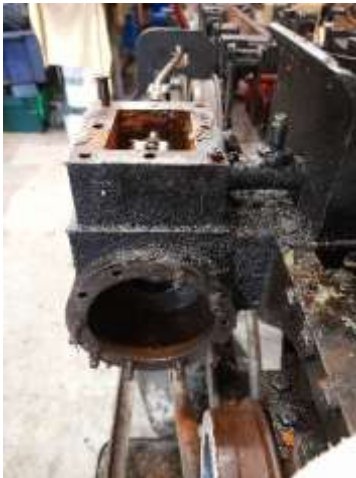
To release the side rod behind the cross head meant moving piston, and, as for the left side, this was stuck as well, so I repeated my actions here (valve cover off, cylinder end cover and plenty of penetrating oil). This side was more worryingly rusty though, looks like an imbalance in the oil pump for the cylinders: memo for later.

Fortunately, most of this was surface rust and after some careful scraping, oiling and 'urging' the whole lot moved again the other side. I think that the cylinder is OK, it was not pitted but I will have to remove the valve check out the valve seat, as this is hard to get at in situ. Interestingly, although I could not access the rear part of the cylinder, it runs freely and shows no signs of rust at that end (ie no stained penetrating oil dripping out, stiffness or other problems). Note that I removed both steam operated drain cocks as well to allow me to squirt oil into the

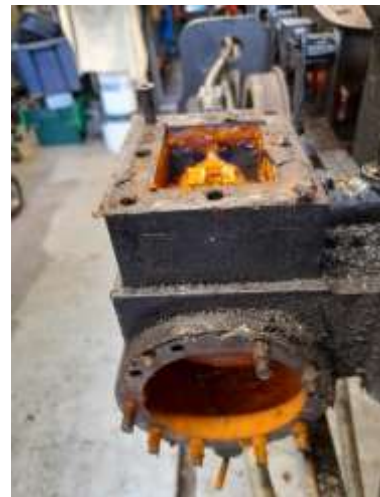
Now that the cross head moved, it meant I could remove the side rod from this side as well. These are all roller bearings working on steel crankpins and look in good condition. The main crankpin with side rod and connecting rod is worn but not pitted, but I think I will leave that (both sides) and no doubt have a small 'clank'. The other pins are OK. I have taped up all of the bearings on the now-removed side and connecting rods to avoid the loss of any roller pins and labelled them: previous restorations of other things has taught me that whilst it looks obvious what they are and where they go when you remove them, you will have forgotten all of that when you re-assemble!

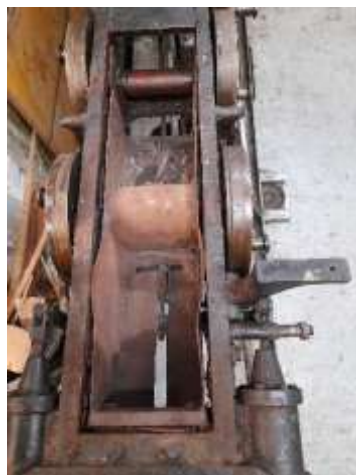
In the spirit of removal, I thought I had better tackle the ashpan. This is a fixed installation (when the boiler is in, it is there for ever) and needs to be thought out a little, as you cannot drop it to release the fire at the end of a run.

Part of this is devising the grate and its fitting too (the grate is missing from the box of bits), and depends on the size of the boiler opening. There was no hope of removing the four bolts holding it to the chassis as it is rusty and will need replacing. I drilled out the bolts therefore and released the ashpan whole so I have the key dimensions if I want to copy it. It was not quite as rusty as it looked in situ, but mild steel is not really

the stuff to make it from, so I will have to dust off the TIG welder I have and make it from stainless steel. Before I do, though, I need to sleep on an improved

design, ideally to enable the grate to be removed after a run, to provide adequate draught for the fire, and yet to avoid spilling hot ash (or cold for that matter) onto running parts of the engine. The rear axle, that runs in the tunnel in the ashpan, is caked in oily ash, as are all surfaces at this end of the engine. The design does not allow much change as the big bits of the engine in the way are fixed (axle, compensated brake gear etc), but improvement seems to be called for.
