Fitting Handrails, Handrail Wooden Top

This document was written by Paul Naylor and is published here for FMES online viewing, and was written during 2025.

Sundowner - 25

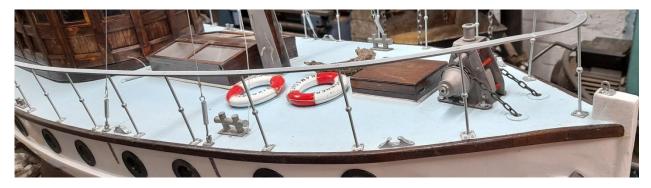
cabin) enjoying 'extra spring' that had to be tamed with a little careful bending. If any uprights fail prematurely, it will be the last one on the port side before the step to the rear deck: it seems to be holding the spring down. In the photo above you can see a brass pipe on top of the rudder shaft: this is part of the future rear flag staff and will be stabilised by a bracket to the rail top: more of this later.

It all looked OK, so I made three more rounds of the deck with the rest of the pins. The rivet set did a

reasonable job, but I then went round them all with a flat punch to make sure they were home, and also to encourage the soft brass flange to take up the shape of the deck. The use of pipe cleaner and

tissue and meths cleaned off the surplus glue and a dab of 'silver grey' paint on each pin head completed this bit.
