“Old Rube restoration part 10”

This document was written by Paul Naylor in autumn 2025 and is the eighth article in a restoration project. The articles were published more or less simultaneously in the Frimley and Ascot Locomotive Society newsletter.

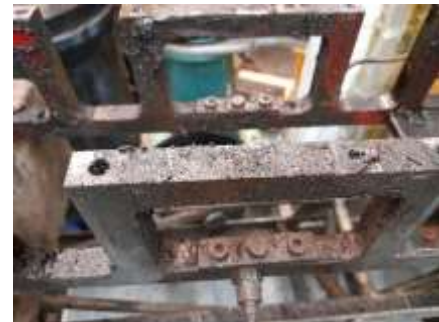
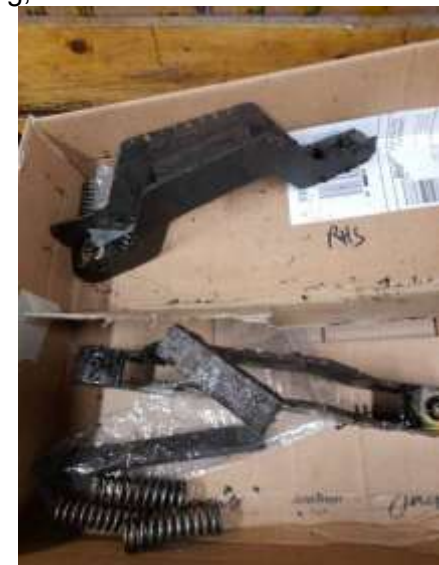
The other side had somewhat mangled screw heads visible, that eventually after much bashing came out: there were screws on both sides of the beam (two on one side, four on the other left). Again, after much more bashing, these came out and I could remove this beam in one piece. This is difficult to explain and hard to see on the photos (top one shows the place where the springs resided in the frame, bottom one the beams, spring mounts and springs), but the long and short of it is that the means of fixing is not satisfactory and I will have to re-engineer some of this to make it more robust, and potentially easier to remove for service, although it will never be possible to make it removeable with wheels and ashpan/boiler in place. Although it would be better to fix modified axle box pads to the beams with screws and remake the bottom spring mount to use better screws from both sides, lack of clearance will probably make this impossible. It rather looks like the axle box pads were just slotted in place and this proved unsatisfactory, resulting in use of a welder (however see later).

I have now cleaned up these suspension parts and investigated them more. The two beams on each side were silver soldered onto the axle box pads, so assembly required the central spring mount at the bottom to be removeable. It looks as though the silver solder had not penetrated some of the joints, only left a dubious looking fillet in the inside corner. Two had parted company completely and one had been held in place with that small weld in one corner. I cleaned them all up, got rid of all the oil and debris with heat, degreaser and thinners to give new solder a chance. '455' silver solder and plenty of flux allowed the solder to flow properly and the new joints look strong enough for use.

Many of the screw holes in the central spring mount were full of broken off screws, so I drilled all these out and retapped the holes... they were 2BA, and, as it 'appens, I have a large number of 2BA countersunk screws from some acquisition years ago. The holes are a little close to the edge of the metalwork and there is thread witness on the surface here and there, and the countersinks 'spill over' the edge of the beams, but a full complement of screws will suffice. I will probably eventually assemble them with copper grease as they are very close to the ashpan and will be prone to drying out and rusting. I elected to paint these components with spray etch primer and satin black paint as they are in a confined space and will rub as they move, rather than the thicker brush painted 'combi-colour'. The photo shows the repaired beams with central spring mount temporarily in place. You can see the threads near the surface, especially on the lower one, unsightly but not seen when assembled, and there is enough thread contact for strength. The hole in the centre of the axle box pads is for oiling the axle box through the pad: they mate with holes in the axle boxes. Reassembly will have to wait until I have cleaned and repainted the chassis.

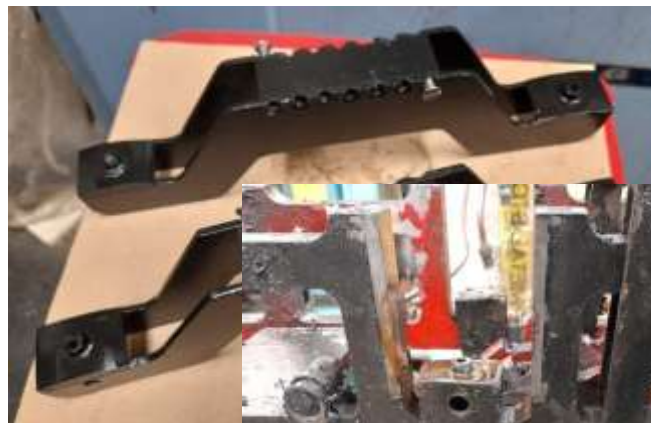
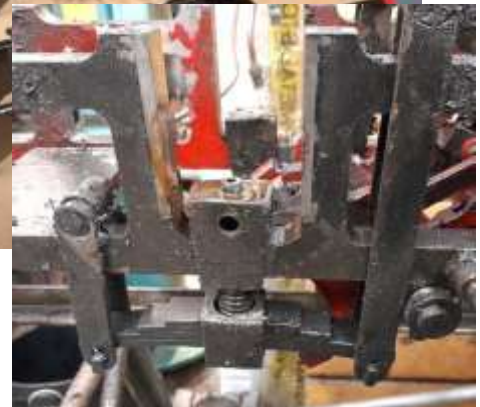
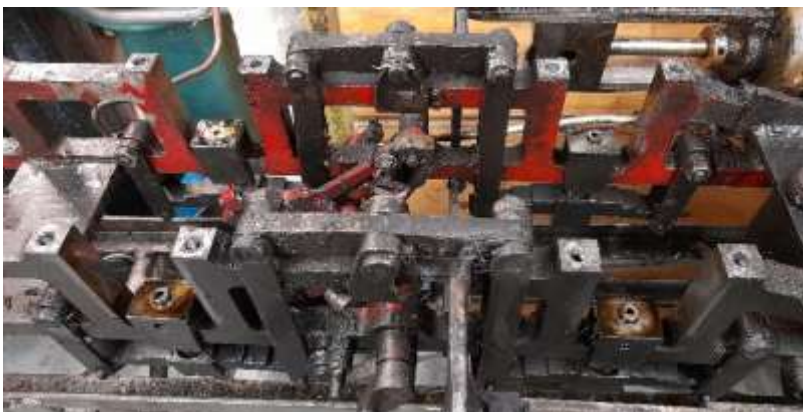
The next job whilst waiting for a tyre is to start on the rear suspension. I need to strip this to paint the chassis as before, although the axle box pads this time use much smaller screws (and they are all there) and I might just chicken out of trying to remove these. This assembly is more involved with more parts (and less apparently wrong with it): here are the photos I took in situ to remind me where it all goes! In terms of further stripping, I intend to leave the
