## “Old Rube restoration part 9”

This document was written by Paul Naylor in autumn 2025 and is the eighth article in a restoration project. The articles were published more or less simultaneously in the Frimley and Ascot Locomotive Society newsletter.

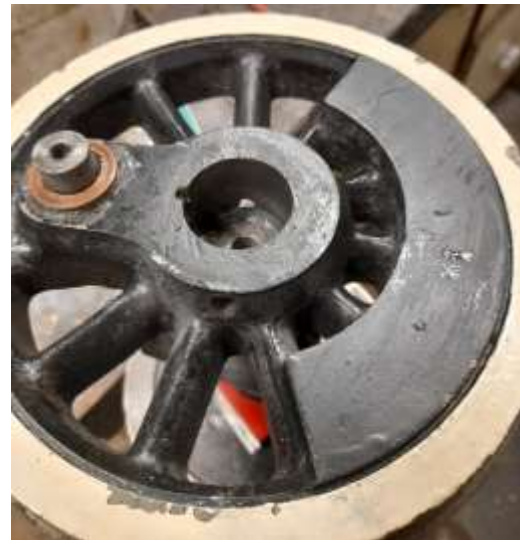
Next step is to remove the wheel. The socket grub screw came out easily, but the wheel would not budge off the axle. On closer inspection, the rock in the wheel appeared to be around a pivot point, so I cleaned the paint off the hub and saw what looked like a pin driven in aslant into the hub and into the axle. It presented as a circular hammer beaten top flush with the hub (and then painted). The only thing to do, after considering wildly trying to inject Loctite into the gap and leaving the wheel on the axle, was to drill it out, so guessing the angle it went in at and going up in drill stages I got to 6mm drill size before I could see what was happening and there was more movement. If I supported the wheel now in my vice and used a drift on the axle end, the wheel appeared to slightly come off. A few more biffs and it eventually came off. The pin was a taper pin all the way through the axle, and out the back hidden by the axlebox. When it came off, this took a piece of wheel casting with it, fortunately just a small piece to allow the taper pin narrow end to leave the wheel. You can see the holes in the photo. I suppose that is one way to make sure your wheel stays on, but it is not recommended. It does not look like any Loctite was used for this, presumably being a press fit originally, unless the taper pin is original and to cure a poor fit – although given that this wheel is the worn one and the one getting the main force of cornering it is more likely that it is to rectify a later problem.

I have cleaned up the axle and wheel hole, smoothed any burrs and reassembled it to see how good the fit is. It is as the estimate above, so my first stance is to use Loctite as planned. I roughed up the mating surfaces a little and used plenty of Loctite 638 after cleaning everything with meths. I am afraid to say that I matched the taper pin ‘from stock’ and fitted this in the original hole: at least you can now see the end of it to

knock it back out, and also refitted the socket screw. It is now curing, so we will see what happens then.

After 24 hours of curing, the wheel is firm and straight, so I am hopeful that this will suffice. It will not 'fall off' anyway, and if I can remove some of the stress on the wheel (see below), it should be OK.
