“Old Rube restoration part 14”

This document was written by Paul Naylor in winter 2025/26 and is the eighth article in a restoration project. The articles were published more or less simultaneously in the Frimley and Ascot Locomotive Society newsletter.

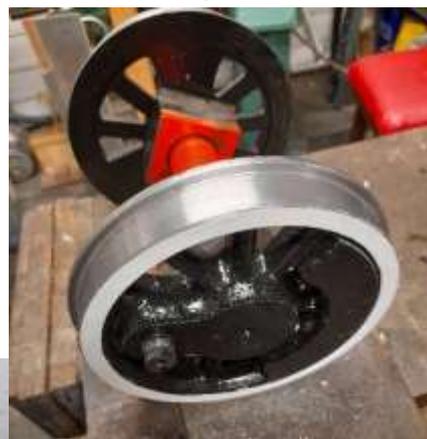
The tyre has now cured, and I can machine it to match the other wheels. When I drew the tyre I wanted, I specified an outside diameter that was very close to the others to minimise the trimming required, but the wheel flange I specified was deliberately too large, so this is where most of the attention will be.

Machining it was straight forward and similar to the other wheels. The tyre had fitted flush with the wheel back and did not need skimming, which is just as well as getting a lathe tool to the back of the wheel in the setup I had was not going to be easy. I used carbide tipped tools for the work on the other wheels (and preparing this one for the tyre), as they were cast iron, but changed to an HSS one for the steel tyre. I did have to turn the flange diameter down and reduce the thickness of the flange so that the wheel gauge I had made would fit OK like the other wheels (taking care to make a root radius to avoid cracking and make a gentler transition between tread and flange). The tread was very close and only needed a light skim as well as adding a chamfer on the outer edge. The Loctite did not budge so that is good of course. Interestingly, the wheel, when glued and pinned to the axle was very slightly out of true: not enough to worry about, only a few thou, but because I machined the tyre mating surface on the wheel after refitting it, the tyre now runs true. I hope the ‘right old mixture’ of Loctite 603, roughening up the mating surfaces of axle, wheel axle housing, and ditto for the tyre plus of course the taper pin replacement and grub screw locator is now adequate for the purpose. A coat of paint makes the wheelset finished and ready for action, or at least re-assembly. The photo shows this wheelset, newly tyred wheel nearest the camera. Here endeth the loco wheel renovation (subject to a satisfactory check on them all with club’s wheel gauge)!

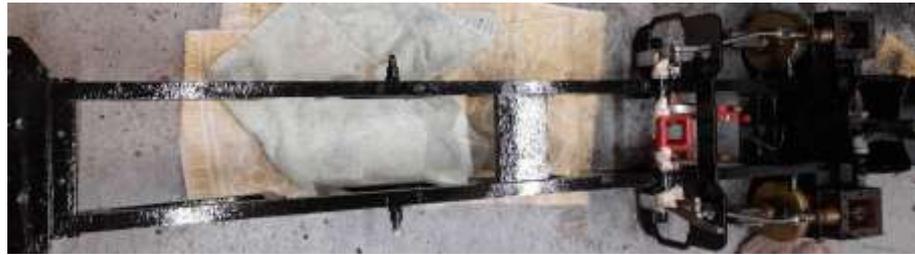
the moment, and I may touch them up afterwards, especially the reversing lever on the main valve gear link lifting rod as this is outside the frames and large (ie

prominent). I did scrape the paint off with a view to leaving it finished steel in colour, but it is not made particularly with this in mind and painting is easier and more prototypical/original. I do need to order some good pigment red paint.

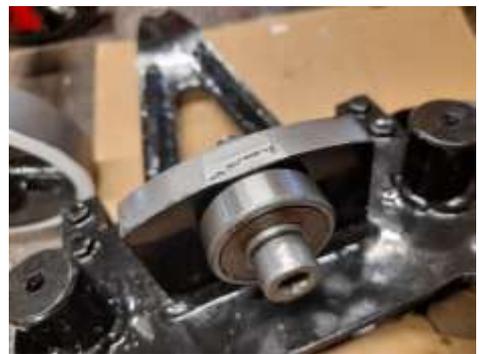
The curved bogie bolster 'bearing surface' is just in contact with the underside of the large frame spacer visible forward of the smokebox saddle, and the spacer has a worn groove in it with a corresponding flat on the bogie bolster that you can see in the photo thanks to the weight pressing on this sliding joint. Although I have painted it, I should really improve the mechanism a little. I could bolt a thin piece of hard-wearing metal over the wear on the frame, but this would be very sacrificial and not help with the freedom of movement of the bogie (stiffness here probably assists the loco round corners, but it is not very controllable). The solution I opted for is very simple: just bolt a suitable bearing onto the bogie bolster for that to bear on the frame instead of the bolster. This obviously eliminates most friction, leaving the side control as the main force to assist on curves. I had a suitable bearing in stock and a few minutes with a drill and then turning a spacer for the bearing (it has a 12mm hole and I am using a 10mm bolt) saw that completed. If it doesn't work, it is easy to remove and return the loco to as it was before apart from a 10mm hole in the bolster. The bearing sits around 1mm higher than the bolster and this takes up the wear.
