“Old Rube restoration part 16”

This document was written by Paul Naylor in winter 2025/26 and is the sixteenth article in a restoration project. The articles were published more or less simultaneously in the Frimley and Ascot Locomotive Society newsletter.

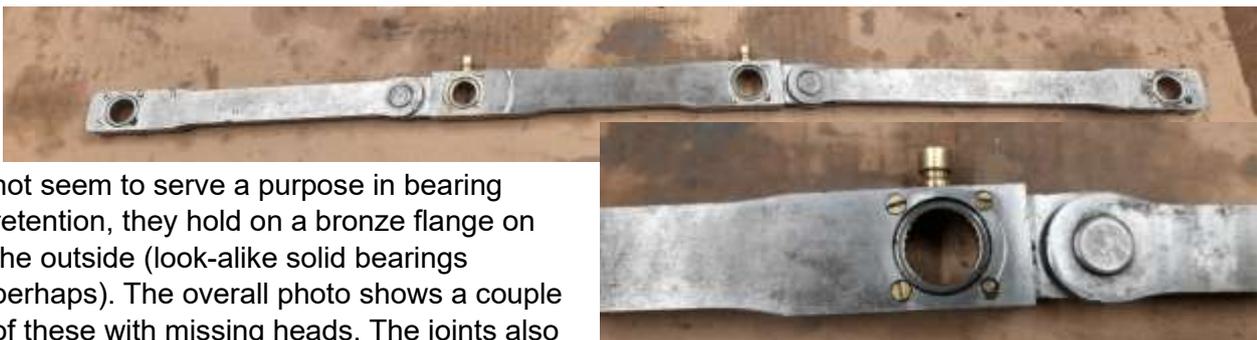
Starting with the left-hand set and getting rid of the treacle revealed that the bearings seemed to be completely bunged up with fairly solid old steam oil and these did not rotate, so I suspect that the bearings probably did not perform as freely as they should. Getting rid of this (and making a note not to use steam oil as lubricant) also revealed the absent rollers in one bearing, so this, at least, needs replacing. The photos show the cleaned up inside view of the connecting rod set, and a close up of the offending bearing (which does not show the missing rollers). The screws visible do

not seem to serve a purpose in bearing retention, they hold on a bronze flange on the outside (look-alike solid bearings perhaps). The overall photo shows a couple of these with missing heads. The joints also

have some slop in them: probably caused by wear because of the unforgiving nature of fitted roller bearings to allow some movement, but I do not think there is anything to be served in replacing/bushing these for this reason. Too much precision can be a disadvantage and steam engines had the reputation to continue working when worn out... The bearings are all imperial and of two sizes (3/4" for the main driving pin and 5/8" elsewhere), fortunately I was able to buy a replacement for the offending bearing.

When it arrived, grinding a little bit of the casing was nerve wracking but quite easy, and a flush with WD40 to get rid of dust seemed ok. It spins without any issues (ie no grittiness). Removal of the old one was a matter of drifting it out and pushing the new one in with a smear of Loctite to hold it there... I wonder if the loco originally had solid bearings that wore out and these were bored out for the roller bearings leaving the brassy surrounds held in with four screws each?

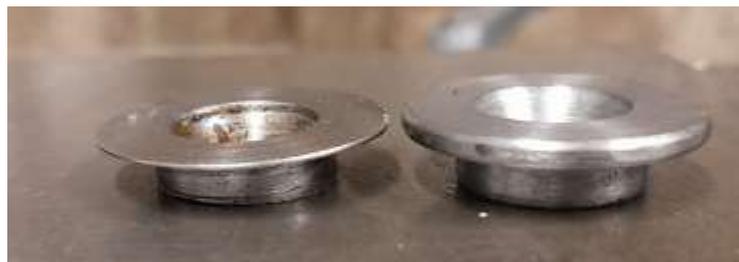
And so, on to the right side. This one is similar to the left and bunged up as much with treacle (and with full complements of roller pins), however it has three properly fixed oil pots and one missing. I turned up another oil pot, cleaned the bearings and the rest of the connecting rod up and fitted it to the respective crank pins. I then tried to see if it all rotated ok without binding... it did (possibly this is not a surprise since it is well worn in) and I could 'get on'. Most of the pin retaining caps fitted OK on this side (ie the connecting rods had a little float), however on closer examination, the two caps on the front wheel set needed some attention. This pair are behind the cross head, and need to miss it when the wheelset is at its extreme range of lateral travel – this is also the leading set that gets most force in cornering. The retaining cap on the right-hand side is worn really thin, presumably in contact with the cross head although there are only small witness marks on it. I had

presumably in contact with the cross head although there are only small witness marks on it. I had

to remake it to give a reasonably good clearance with the cross heads and provide some retaining strength that was failing on the old one. This was a simple turning job, but with a need to adjust size etc to make sure that the connecting rod had some freedom of movement and it all missed the crosshead. For some reason (yet to find out?), each connecting rod pin has TWO bronze washers between the wheel and rod, each around 1mm thick. To eliminate risk of crosshead contact, I had to get rid of one on this front wheel set: time will tell whether this is a problem or not. It always surprises me (on my own locos as well) that a really large design with apparently loads of space for components, inevitably has some places where space is at a premium! I then 'loctited' (Loctite 270) the bolts in while I remembered to do it. On my locos, these retaining caps were held on with right hand threads on the right-hand side, and left-hand threads on the left, so when running forwards, they had a tendency to tighten: here there is the risk that the ones on the left-hand side unscrew themselves without retaining glue (shades of 'knock off' wheel nuts on older cars). 270 thread locking compound can be unscrewed with a little difficulty, but it will soften above 150 degrees C to allow easier removal. So far so good then, the next job is probably re-attaching the slide bars and cleaning up and refitting the main connecting rod to continue checking it all works as intended.
