“Old Rube restoration part 17”

This document was written by Paul Naylor in winter 2025/26 and is the seventeenth article in a restoration project. The articles were published more or less simultaneously in the Frimley and Ascot Locomotive Society newsletter.

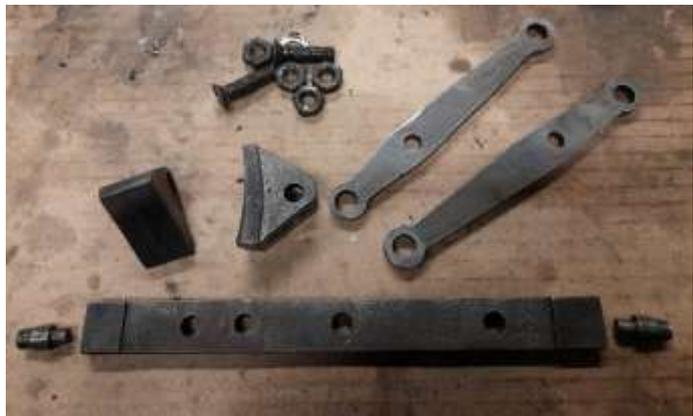
treads on the cast iron brake block is shown in the other photo (left)...it is the same for all brake blocks, there being three wheelsets braked with the unflanged wheelset not braked, perhaps because there is very little clearance for a hanger between this wheelset and the driving set. Although it is not desperately clear, you can see the two levels in the block worn in contact with the worn and unworn parts of the wheel.

The pivot pins were silver soldered into their holes as an easy fix. I ‘ummed and aahed’ about the brake blocks. The purist way would be something like bolting them to the lathe faceplate at the desired radius and ‘boring’ them out or similar and I did contemplate this. Out of curiosity though I tried one on my linisher (on the end pulley), using the most worn bit as a guide to radius. I ended up doing both this way as it was quite quick and easy

and the blocks did not rock or have large uncontacting areas when placed on the wheels. Remembering that they will wear in to the wheel, I thought this was adequate and will do them all like this. Paint came next (etch primer and spray satin black here). Having done one of the three sets, I moved to the driving wheel set: very similar except that one cast iron brake block had been replaced with a steel machined one, presumably a long time ago as it

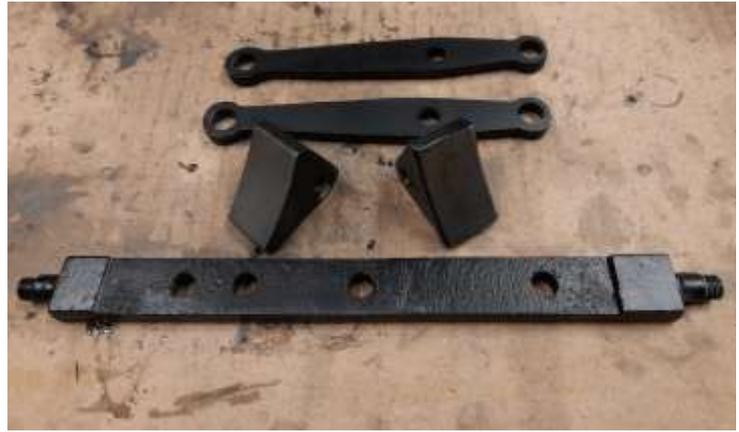
was as worn as the rest: it also has a machined step in the outer edge for some reason (maybe a machining error). This set also presented the conundrum for the week. The brake linkage, being balanced so that equal force is applied to each wheel, has to avoid the 'earlier' brake stretchers (the bottom bit in the above photo) and this happens with welded up sections that the stretcher passes through. The driving set has such a section (see photo left: uncleaned) but it is not large enough to remove the stretcher for this wheel

set. The ends have bits welded on for the hanger pivot pins that are larger than the slot in the link section. Looking at the loco, this stretcher cannot be the same as the others as the axle spring beams get in the way, so obviously this is to avoid these. I will have to arrange something to allow this to be dismantled methinks... maybe make a bolted-on bit in the link section. The brake arrangements have many clevis joints, and the good news is that these are all commercial components with split-pinned pins as pivots. They all look in reasonable condition (if dirty) so that should speed the work up a bit. To make up for it, the longer links like the above photo are quite crudely welded and tidying them up a bit will be good.

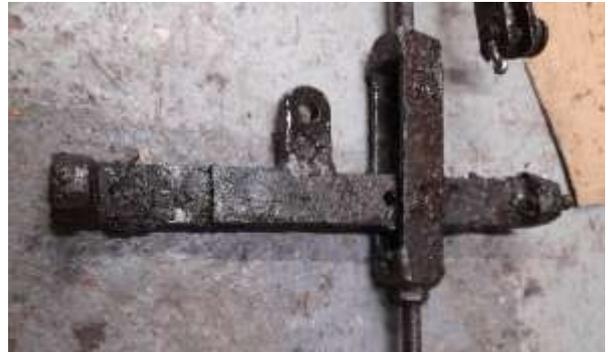
I cut the link as planned to get this apart and cleaned it all up. This revealed a lot of 'running repairs' as the brake stretcher, under all the gunk, was bent. Both ends were welded on, one looked like done in a rush (!), bearing the marks of a good old wallop presumably from a derailment. A lot of the brake

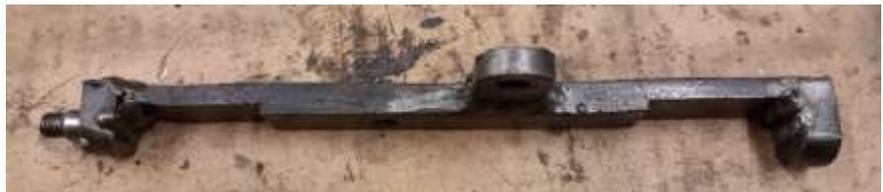
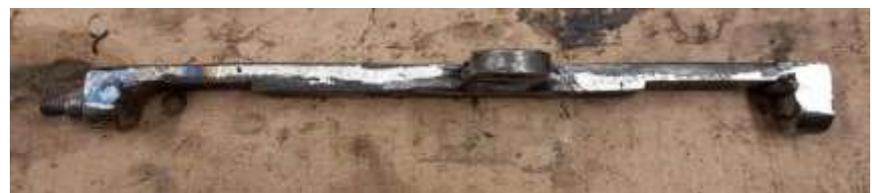
linkage rods were also bent a little maybe from the same happening. Although I am making things straight and functional, I am not setting out to replace parts just for cosmetic reasons (apart from cylinder cladding!), these are part of 'patina' and loco history, repairs here were called for. The top photo is the misshaped stretcher (right hand end on photo) before and then after cutting the end off and rewelding it back in a better place. The shine is having skimmed it with an angle grinder... still to be painted etc. Note that in both photos, the brake hanger pin is missing from one end... yet to be fixed back in place. The bits and pieces like this stretcher were rust pitted and so, after cleaning, I resorted to 'rust converter' again prior to painting. Most of the clevises and their pins were still plated and so these will be left unpainted.

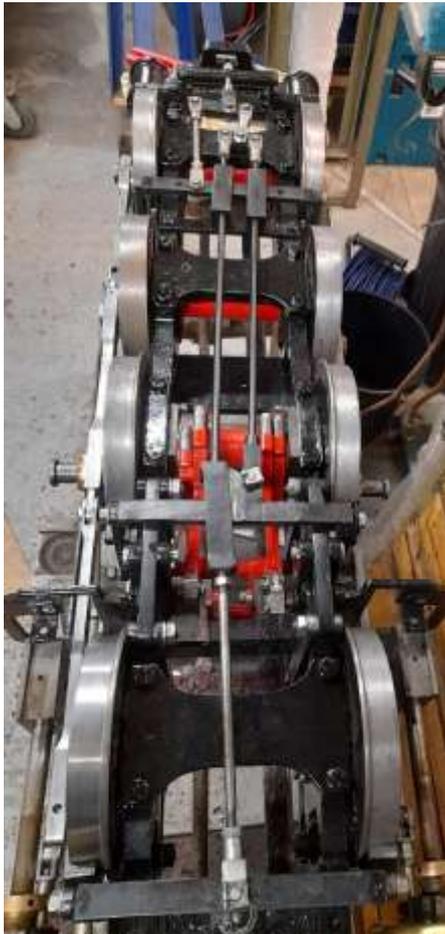
The pile of bits to be refitted look like this after painting. You can see the modified bypass section at the bottom: it has a bolted on 'hatch' to release the rod without the stretcher

now. This does not show the

clevis pins, most of which are commercial headed plain pins with a machined recess near the end for a clip to match the clevises. Two were replaced with bolts for no reason I can see, so I made up two more so they are all the same. Two are existing 'quick removal clips', but apart from one split pin at the brake cylinders end, the rest are 'E' clips from my handy box. After some referring to pre-disassembly photos and other fiddling, I eventually got it all rebuilt with appropriate travel on 'the system' to enable operation by the brake air cylinders. Experimental wheel rotation shows it all misses the connecting rods as they rotate: now it is back together, it is clear that the damage to the brake stretcher came about after a meeting with the adjacent connecting rod for some reason.

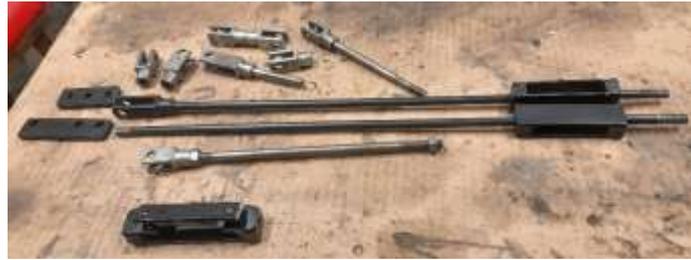
It is starting to look more complete now... note that although the side rods are fitted, the slide bars and main connecting rods are not, and that is the next task.
