“Old Rube restoration part 18”

This document was written by Paul Naylor in early spring 2026 and is the eighteenth article in a restoration project. The articles were published more or less simultaneously in the Frimley and Ascot Locomotive Society newsletter.

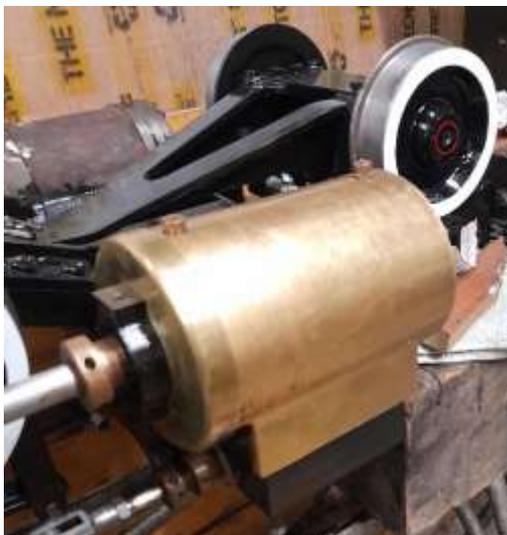
Point duly passed... they are flat! Actually, only one is as they are identical (I checked). In the end I only used it to mark out the position of the drain cock holes and for the length round the cylinder. The long ‘ears’ you can see on the old one in the photo did not seem to serve much purpose, so I did not waste brass with these. I am fortunate in having an elderly set of small bench rolls which is ideal for this sort of thing, so rolling the cylinder cover was easy. I have avoided using any heat for any reason and the brass remains hard... and springy, so they ‘snap’

over the cylinder nicely with the end covers

snugly holding them in place. It means I do not need to drill the holes for the little screws holding the old covers on (7 screws on each cover). The photo shows the left hand one, right hand one yet to fit. I could polish them right up, but they match the end covers quite well as they are. When I made my US 1850's wood burner, I made loads of brass ‘bling’ as befitted the style of the day and buffed and polished it to nearly a mirror shine. You needed sunglasses to look at it, right until the first run when it all dulled down and although I ‘Brasso’ed it a few

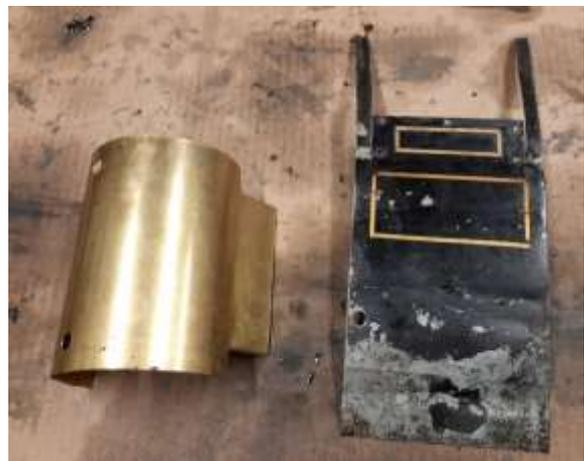
times, my enthusiasm for this activity soon wore thin and it all looks like the above photo now. By the 1880's (when prototype Old Rube was made), I think it also wore thin in real life and locos started becoming black and boring - if a future owner wants to restore it to black, paint is a wonderful invention.

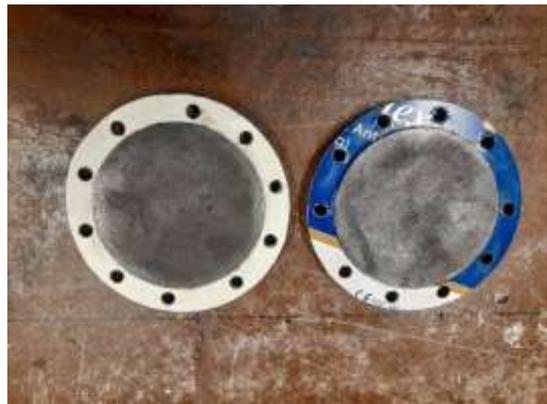
Since I have made the cylinder cladding now, and need the covers on TWO ends of each cylinder to hold it on, I should probably next refit the front cylinder end covers. These were removed to de-treacle the cylinders and get the pistons moving freely, and I only attached them back with a couple of studs to keep muck out during all the cleaning and painting. I don't want to do this twice, so these need to be refitted steam tight ready for use. When I removed them, more than half of the studs came out with the nuts, so there is some work to do. I ended up replacing some of the studs as they had been unceremoniously hacked off flush with the nuts leaving a ragged end (why the nuts did not come off instead of the whole stud). I tapped out the holes (1/4" BSF) to clean them out, and cleaned up or replaced the studs, secured with some Loctite 270. The cover sealing had apparently been done with just a silicon-based sealant and no solid gasket so I scraped this all off both mating surfaces. Although no doubt effective, I don't like silicon sealant as it goes off quickly, oozes out possibly internally (to bung up drain cocks etc) as well as externally and a tube of it always seems to go off if stored for more than a week or so. I assume that this is the reason it seems all you can buy (you throw 80% away after using it once or twice), a tube of old red hermetite lasted for years. As I usually do, I made up some card gaskets (cereal packet or similar seems to work for me) and got some 'Hylomar' gasket compound that says it semi-hardens. We will suck it and see. This is smeared over both sides and then the joint re-assembled. The photo shows the gaskets on their covers pre-sealant application (and in one case gives away the provenance...). The stud holes are made using gasket punches, not something I would usually buy (I used to use a sharpened piece of tube), but I found a complete set in a charity shop for £5 (about 20 punches of different sizes) so why not? I am not sure the charity knew what they were. I don't suppose the CE mark on one gasket applies for this application though. Before fitting I liberally applied oil to the bore, including some through the drain cock holes for the still sealed rear ends.

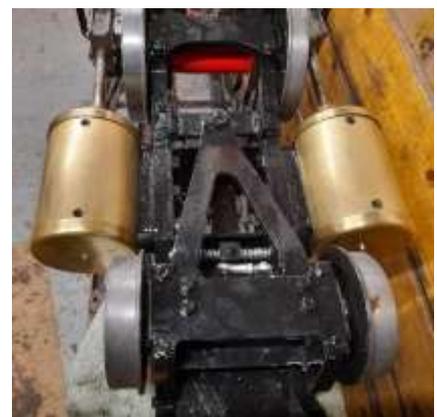
After some messing around (including replacing an old stud that pulled out when I tightened the nut owing to too few threads in the casting) and suitable marine language, I eventually got everything sealed up. I replaced the single 6BA brass screw on the front cover ends with a stainless steel M3 stud (tapping out the cover hole) for a little more strength. I could now fit the drain cocks that I restored a while ago (and a pipe set to plumb them in that I discovered in the rats nest of piping I had), but I will wait until the chassis is ready for turning over as they are potentially vulnerable.

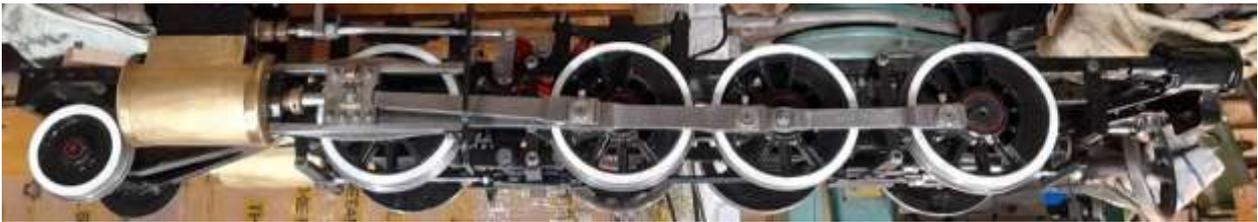
It appears that the flats machined on the cylinder end covers for the guide bars are more or less bang on for the crosshead, so no shims are needed here. The rear end however, supported by the cross frame, is a different picture with some quite large gaps to be shimmed. A motley collection of shims (and, being frank, spacers and washers) came from it when disassembled, so I thought I had better start again and make up brass spacers the right thickness. I selected a sort of compromise spacer for the lower guide bars that halved the amount of vertical play in the crosshead. This turned out to be 0.030" for both sides using feeler gauges. When the lower guide bars were fitted using this, I could then clamp up the crossheads and guide bars together (when extended) and measure the spacer required for the top ones. One was another 0.030", but the other was more like 0.1" (hard to measure: feeler gauges no use here!). The latter one took some fiddling to get right (I made it too large and filed it down in stages) but eventually I had a smooth moving shake free crosshead on each side. The net result is not easy to see on photos.

The task of cleaning and refitting the connecting rods was similar to the side rods: scraping off treacle and freeing the bearings (which were in good condition). One rod needed a new oiler as per the side rods. The left side already had spacers between the connecting rod and side rod and was lined up OK, the right side had no spacer but when assembled, needed one just under 0.125" thick, so I had to make one using a short piece of gunmetal I had of the right diameter. When turning such things from solid (and expensive) bar stock, I try to avoid making too deep a hole in the middle and used a 0.5" slot drill held in the tailstock chuck to make a hole and then bored it out to the 0.75" diameter required. I ended up using only 3/16" off the end of the bar stock including parting off, which retained an unmarked surface for next time. When built up and everything in place, it all turns freely with no binding or shake except for about 0.01" end float at the wheel crank pin. And thus ends the refitting of the important bits of the chassis. The photo below shows the left side apparently right way up, but actually still inverted (I turned the photo upside down, it's easier!). Since there is no weight on the axles, the wheels have adopted a 'free position' thanks to the compensation and look a little out of line.

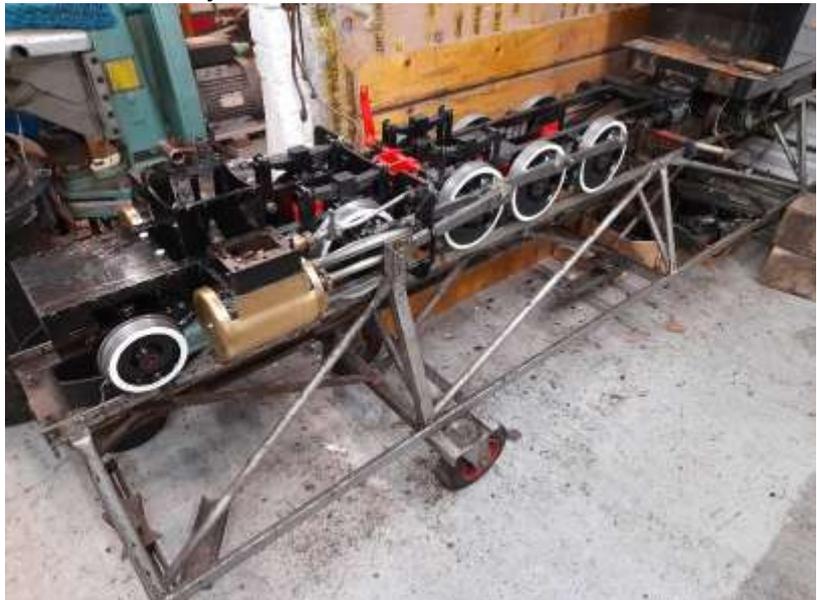
turned, as it is the wrong way round as well as upside-down. I attached two slings to front and rear, lifted it off the stand and lowered it onto blocks on the floor. I then removed the front sling and lifted the rear end upwards until it was vertical, by then the front buffer beam was resting on many towels on the floor. The bit the wife did not like came next: holding the chassis vertical while I removed the rear strap as well and replaced it on the other side. This meant that I could tip the chassis past

balancing point and let it down to the floor again, this time the right way up AND right was round. Reattaching both straps allowed me to lift it again, this time to put it back on the rails. In the end, easy and used more adrenaline than physical effort. This is where I remember what I had forgotten to do while it was upside-down... but at least it is on all fours and I can carry on with topside work.
