“Old Rube restoration part 20”

This document was written by Paul Naylor in spring 2026 and is the twentieth article in a restoration project. The articles were published more or less simultaneously in the Frimley and Ascot Locomotive Society newsletter.

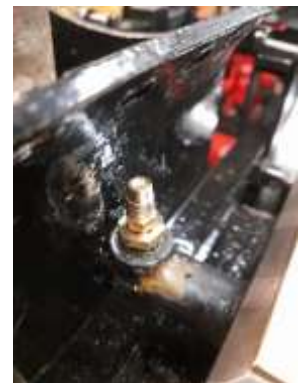
The oil is piped into the steam delivery pipes just before they go into the cylinders and there is a non-return valve (a ball and spring) that the pipe feeds into. These were poor condition and full of treacle and so I decided to remake them. One of them sheared off when I tried to remove it anyway. A small bit of machine work followed resulting in two new delivery valves. The photo shows the left hand one.

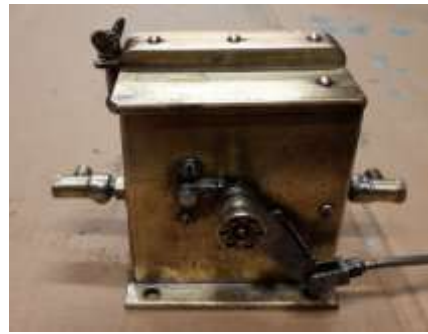
superheater steam delivery pipe before it separated into two for each cylinder. To do this here would mean modifying the large steam pipes in the smokebox and I decided that this was a step too far. On Old Rube, the oil was pumped well by one cylinder (the one that had apparently worked well), but barely showed and had little pressure on the other, confirming one theory anyway. The problem is that the builder had made it so it was not possible to disassemble it by silver soldering the ratchet onto its shaft, removal of which was necessary if I was to take the whole lot out of its box. I managed to get the offending cylinder out 'in situ' with very fiddly work by removing the nut on the cylinder spring: it was in good condition though and since this has no valves (or wear) I ended up putting it back. I concluded that the primary non-return valves in the oil pump were not working and checking these revealed that one had no spring (where did it go?) and a rusty ball. These can be seen on the sides in the photo, the one on the left was faulty. It also had very worn and short threads on the body for pipe nuts, and some soft solder to seal leaks presumably. That meant making another non-return valve, fitting it and trying to pump oil again. This time it worked and had some pressure, but not as much as the other side. I decided to use this, rebuilt it all and fitted it to the loco with new pipes to the [new] non-return valves on the steam pipes. The photo shows the result of this lot of work, smart looking cylinders and hopefully a working oil pump!

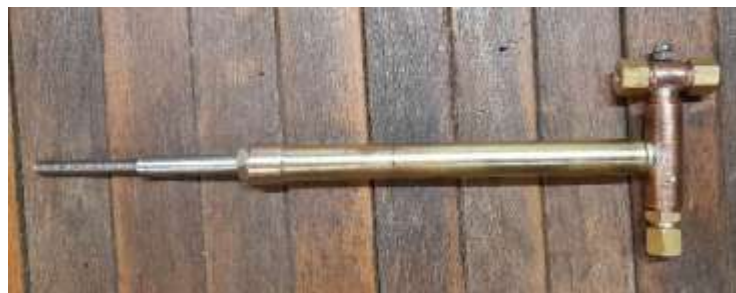
pressure, and the suction would not cause cavitation: both appeared to be tenable, so this is the design I used. Again, if trial and error shows problems, I can take it off the loco easily and remake it. The photo shows the pump ready to have a mounting made and coupling to the crosshead. The valves end is made of phosphor bronze rod with free stainless steel balls. The suction side ball (in the lower part in the photo) is limited in travel by a stainless steel pin through the body, and the upper one is limited by an adjustable stainless steel M4 plunger/adjuster you can see in the middle of the top 'tee'. The top tee has two outlets: one will go to the clack valve on the boiler side, and the other back to the cab where the bypass valve will be fitted. The threaded end of the plunger will have two adjustable stops nutted onto it for a yoke attached to the crosshead to work. This will have float so that there is no rigid connection to the cross head to cause less strain on mountings and bushes etc. It is all screwed together to make disassembly easy. I have used adjustable ball lift limiters like this one on a number of locos now. A good few years ago, I made a Martin Evans 'Holmside' tank loco and the two clacks I made for water delivery had turned bronze caps with a carefully measured integral ball stop machined in to supposedly the right length. They worked well for something like 20 hours of running and then one started to misbehave (the axle water pump one). I took it apart and found that the machined in stop (about 5mm long) had vanished and a crater had formed in the cap in its place. I put this down to the ball oscillating in the clack (especially on axle/crosshead pumps as the water flow is intermittent but rapid pulses) and wearing the stop down. Replacing this with a screw adjustable stop allowed me to set an ideal ball lift by experiment and it did not wear out...

While sitting pondering the loco, I started thinking about the idea for a crosshead pump. I ferreted around my metal stocks to see if I had enough bits to make one up (I was reluctant to start buying stock if I had adequate supplies). I therefore designed the pump around what metal I had (!). The pump body is a piece of thick-walled brass tube with an internal bore of 10mm, a little larger than the 8mm my calculations suggested. I did, however, have some 5/16" diameter (c8mm) stainless steel rod for a plunger (as calculated earlier in article 11). I thought about just using this in the large bore (it would still pump in principle), but I did not want the end to be able to 'waggle around' in the bore, straining the bushes at the end, so I initially made a piston that worked in the bore but was 'leaky' to stop air locks and other problems in the closed end. Further thought, and the fact that the tube bore was very good as a sealable surface, made me decide to fit a proper piston to the end with two O rings for sealing it, and have a small hole in the closed end to stop air or water locks and get rid of any blow by. This, of course, means that the pump has a working bore of 10mm not 8mm and will over deliver water. Hopefully, this will be OK as long as I have a good bypass valve fitted (more on this later). I spent a little time working out the likely speed of water in a 1/4" delivery pipe with the loco going at a reasonable speed and the extra pressure that this might cause (and whether the water would cavitate on the input side). These calculations placed some strain on my very rusty hydrodynamic knowledge but the conclusions were that the pressure would not exceed about 1.5 times boiler

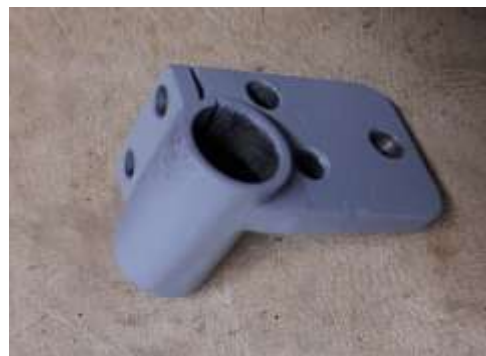
The bracket to mount the pump to the slide bar frame is a machined-up lump of steel now that has a hole for the pump body that clamps to it (M5 bolts closing a split housing) so the position can be adjusted (the pump maximum throw is 108mm and the stroke is 100mm). This is to be bolted to the frame via three M6 bolts so that the pump is above the frame not through it (this would require a substantial hole in it that I wanted to avoid), meaning a long-ish connecting link to the crosshead. It all fits easily inside the maximum width of the loco across the cylinders, so it should not catch on anything but it is not protected between the slide bars and loco frame as this space is full of wheel (unlike my 4-4-0 US wood burner).

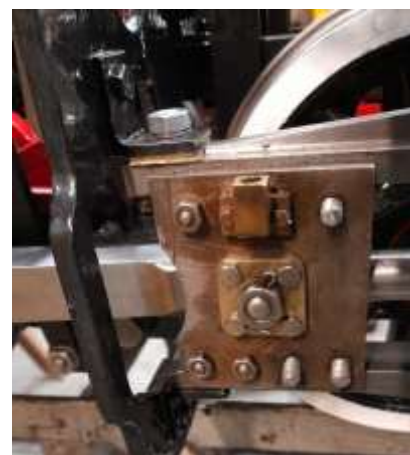
The final item of this fitting is the lever to connect crosshead to pump and its fitting to the crosshead. Fortunately, the crosshead is a plain lump of cast iron with six cosmetic studs and nuts at top and bottom. Investigation revealed that these are glued (or pressed) into plain 3/16" x 1/2" deep holes in the crosshead - application of a spanner loosened them and they could be pulled out. On the one hand this means that the holes exist and three can be co-opted to secure the link to the crosshead, on the other though it meant I had to tap them out M6 for 'proper' studs that are obviously overscale. I will use tapped out M5 nuts for fitting to make it look a little closer though. The photo shows the crosshead with the three M6 studs in place ready for the link. It also shows the slide bar frame, although the three tapped bolt holes for the pump mounting are out of sight at the top.

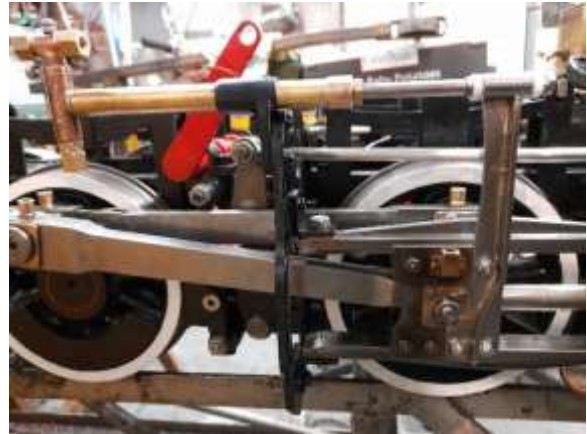
The link was made from some cold drawn mild steel plate 1/8" thick with a stiffening piece and the drive boss silver soldered on (I used 638 silver solder as it is cheaper than 655!). The engagement with the pump rod 'floats': it has an 8mm hole through it for the M6 threaded pump rod and nuts provide the location, with two pieces of PTFE to cushion the impact from the link. When installed, the pump rod was parallel to the crosshead movement to less than 0.3mm over the stroke, but I imagine that vibration, heat and other movement will happen to require the – hopefully enough - float. The photo shows it all installed on the engine, and the image also highlights the silver solder that is a bit of an eyesore in this view. It is less obvious on first glance at the real thing, but I elected not to paint it, in keeping with the surrounding metal, at least to start with. It all seems quite stiff where it needs to be and able to withstand the forces (around 7.5kgf I think), but the proof of the pudding is in the eating of course. If a future owner does not like this non-prototypical device, it is removable leaving only three M6 holes to plug in the slide bar frame.
