## “Old Rube restoration part 21”

This document was written by Paul Naylor in spring 2026 and is the twentyfirst article in a restoration project. The articles were published more or less simultaneously in the Frimley and Ascot Locomotive Society newsletter.

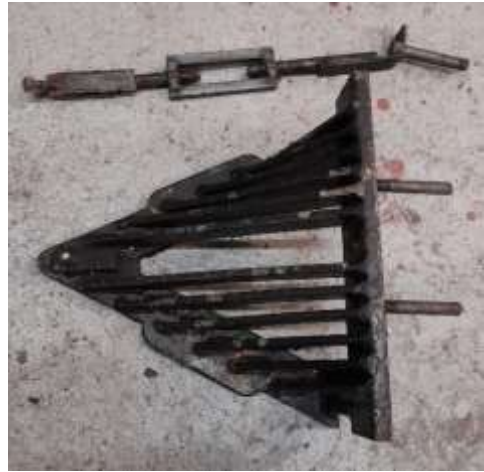
The main event here though is working out how the 'cow catcher' fits. This adds about 200mm to the loco length and naturally it looks bare without it. It is a heavy fabricated welded steel structure with two unthreaded prongs that push into holes in the front wooden beam, and through the steel chassis behind it. In the box of bits, there is a turnbuckle-based stretcher that superficially looks like one end is bolted through the buffer beam central hole, and the other end over a pin at the front of the cow catcher. However, this seems too large to fit (the screws are rusted in so I didn't bother testing it) and is a little crude to be on display anyway, so I suspect a little re-engineering will be called for here. The turnbuckle idea is good though as it makes it fairly quick to loosen and remove. I will need to strip and repaint the cowcatcher and can think about reattachment

while doing this. I started to see how hard this would be, first by scraping the paint, but this is difficult in the angles. Then I tried grit blasting, and it does work but takes a long time and gets lots of paint flakes in the grit (which is reused and big flakes will block the feed). The third resort is paint stripping. Fortunately, this lump of steel is not a thing of precision and fineness, and has no moving parts etc, so a good soak in caustic soda should do the trick. The shape is a pain as it is too wide to go deep into a conventional bucket (or use loads of soda to cover it), so it looks like two or three stages of dip. As a tip, I found that Dyas, the High Street household shop, have small but handy containers of certain useful chemicals on their shelves. In particular, they have granulated caustic soda and ammonia.

The snag with the caustic soda stripper is that it can take ages, so it is best to plan ahead and leave it soaking, maybe even for a week at room temperatures. I believe that commercial caustic soda strippers use elevated temperatures to speed things up, but I use a bucket and time... and reduced hazard from hot caustic. The reaction when caustic soda granules are mixed with water is exothermic, so it gets hot itself to start with. In fact, if you add the water to a pile of granules, this can be so fast that the water boils and spits concentrated caustic soda everywhere (which is guaranteed to remove skin and worse), so always add caustic soda to water and stir it in gradually. I once mixed a very weak solution of this for cleaning down signal poles at the club: it cleaned all right, but I didn't bother with gloves, and even this weak solution gave me red raw rashes on my hands for a few days, lesson learned!

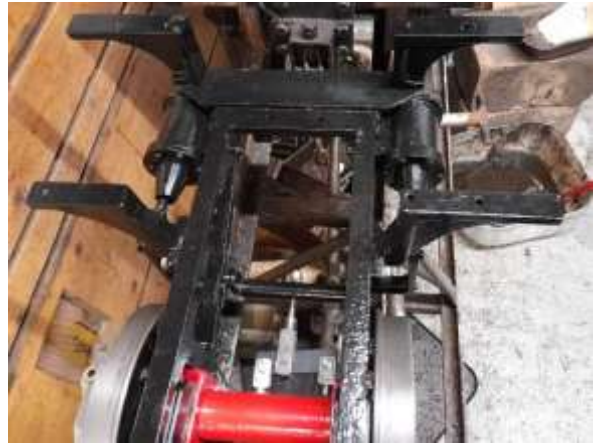
Casting around for something useful to do on the loco while waiting I started looking at the reversing gear. This is a standard ratchet lever type mounted in the cab, and usually it is mounted to the chassis directly with suitable holes in the cab. Here, the ratchet frame is mounted onto the cab floor, and this is elevated above the chassis with four cast iron brackets, so the fact that it needs the cab in place (which itself needs the boiler in place) means that I can't fit it properly now. I

also can't see a reach rod in the pile of bits, so that will need measuring and remaking. One of the four brackets has a hole to receive one bolt through the ratchet frame as the only direct connection between the lever mounting and the chassis, as well as the lever pivot which is mounted on the chassis. At least I can sort out the four brackets and mount them on the chassis ready, and maybe try out the lever mounting. More paint removal (this time with the wire brush), degreasing and then painting. This was only complicated by the fact that one of the rear brackets, mounted via one bolt only to the chassis, had stripped the threads of its 1/4" BSF hole, so I had to drill and tap it out a larger size. For some reason, I did it 5/16" BSF and not M8. The photo shows the brackets in place, the nearer one on the left in the photo is shorter than its opposite number and is the one the reversing frame bolts to with its one bolt. The reversing lever pivot hole is in the upper chassis member between the pair of brackets on the left in the photo.

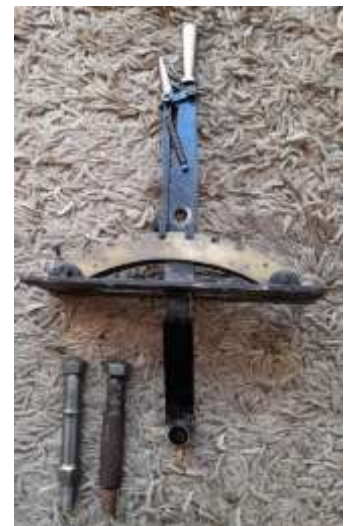
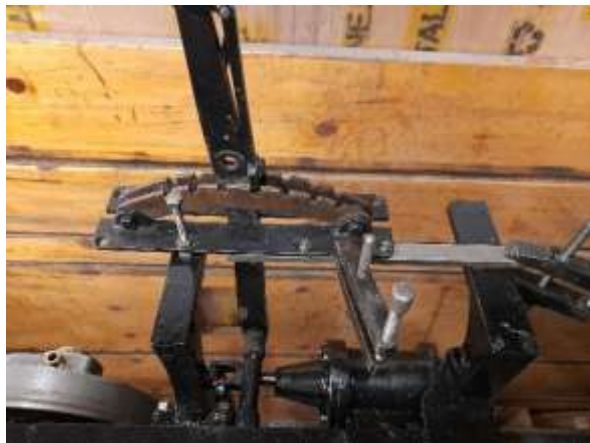
I found the reversing lever pivot in a miscellaneous box: it was bent and marked with Stilson wrench jaws as it is circular and yet threaded 3/8" BSF to go in a threaded hole in the chassis. I found out why it was bent too when I came to try it in situ - it fouls the clevis of the righthand side brake cylinder a small amount, 'fixed' by the bend when bolted up. I thought I could do a little better and remade it from some hex bar so I can use a spanner, and cut away to clear the clevis. The photo shows the lever, the old pivot and the as yet unpainted new one. After cleaning up the lever a little and painting the pivot, I should be able to mock it up to see if I can measure it for a new reach rod.

The lever is somewhat stuck together and I am not inclined to take it to bits just to repaint it, so as long as it fits when it is properly mounted sometime later, it will do as is. In the end, after these photos, I did scrape the paint off as it was flaking, and I have ended up with a raw metal assembly that I will paint the frame bits of but leave the lever etc as bare metal. I clamped it to the chassis in the right place and with packing to represent the cab floor to eyeball it for a reach rod. Unfortunately, it is not in direct line with the valve gear lever and the reach

rod pierces the cab front 'wall', so it is not a simple matter of a straight rod: it will have to wait to be tailored in situ. Or I could mount up the cab and do it properly, but that is a lot of work, and the cab is a little flimsy as some joints have flexed (it is an all-wood construction and will need some attention and glue) anyway. Maybe this was caused by the forces on the reach rod being mainly borne by the wood frame. On the photo you can just see the close proximity of the lever pivot to the brake cylinder: it now has about 1/16" clearance at the worst-case position.

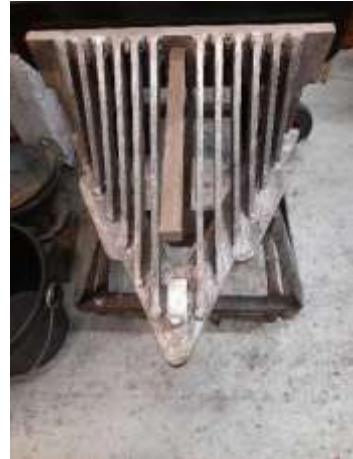
Back to the cowcatcher (or pilot, as I suspect its proper title is). It is now all stripped and then grit blasted. I offered it up to the chassis to see how the securing turnbuckle would fit. I decided to remake the fixture and ordered a stainless steel M8 turnbuckle that I will need to make 'ends' for its pivots. These are ludicrously cheap (around £6 delivered), so we will see what arrives. To be able to remove the pilot easily for transport (it would shorten the engine by 200mm plus), I don't want to use nuts and bolts, and I think I can make something to suit that just needs the turnbuckle to be loosened, then it would pull off the chassis. It has two 3/8" diameter prongs that push into holes in the buffer beam and is secured by the turnbuckle arrangement. The photo shows the mock up with a chunk of 0.5" square steel to make the fixing with through the existing holes (pilot as yet unpainted). That is the next job and for the next article.
