## “Old Rube restoration part 25”

This document was written by Paul Naylor in autumn 2026 and is the twenty fifth article in a restoration project. The articles were published more or less simultaneously in the Frimley and Ascot Locomotive Society newsletter.

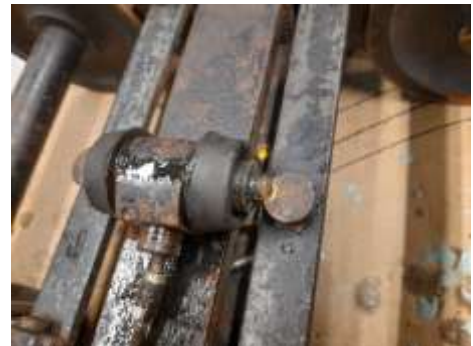
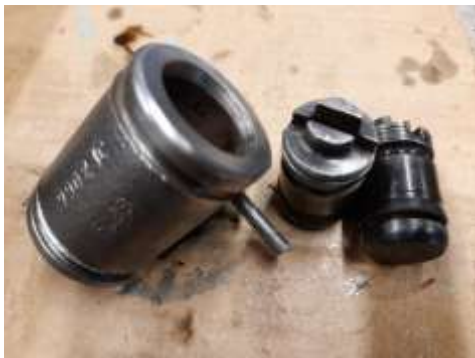
As I mentioned earlier, these appear to be car drum brake cylinders but operated with air pressure. The photo shows one in situ: when pressurised, the two ends are forced out, engaging with the brake beams that then apply the brakes. These ends ‘float’ so there is no force on the cylinder itself (and small differences in brake position are taken up too). I have already unscrewed the pipe union and applied WD40 elsewhere to make it easier to disassemble. I approached this with some trepidation since my experience with car rear drum brakes include dealing with a rusted lump, unions that shear or round off when unscrewed and pitted and stuck pistons... why would this be

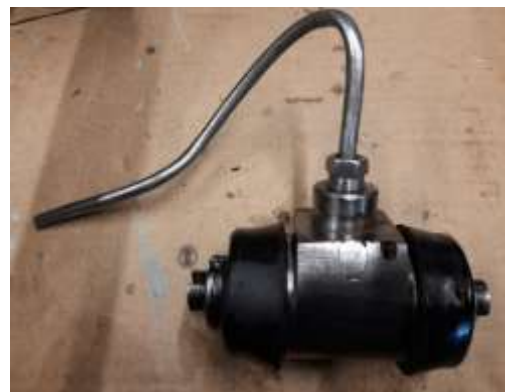
any different? In fact, it all came apart really easily, and reminded me how elegant and simple these are. When disassembled and cleaned up, it was obvious that there were no problems (apart from a slightly cracked rubber end cover), and even the lip seals internally were fine. The photo shows the working bits, with a 2BA stud in the cylinder to hold

it to the chassis (it only has to support its weight). It also shows cast in markings that led to an interesting 30 minutes with the web browser (and AI helped here too) to try to find the origin. Eventually, I narrowed it down to a

standard rear drum brake cylinder of around 1980 for, amongst other things, an Astra Mark 1. If I believe AI, then I can get a repair kit for these for £10 or so, and I will decide about this when I deal with the other cylinder, as all I really need so far is a single rubber end cover. The cylinders have been externally modified however: the bleed valve hole has been blocked up, some lumps and bits machined off the outside and the mounting stud added. The assembly photo shows the result of the examination (including the blocked hole etc). The pipe (a standard car brake pipe) had a simple pushed on and jubilee clipped hose for air supply, and that might have to do as the pipe threads through a small hole in the chassis that a fitting would be too large for: watch this space.

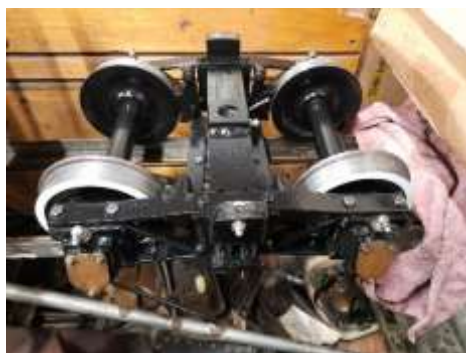
Well, I 'slept on the bogies' and decided that since the rest of the engine is nice and shiny, and the tender as a whole will be too, the bogies had better put in an improved appearance. One by one, I stripped the wheelsets off them (four bolts each through the bogie chassis, the springing is on the central bolster) and turned the (slight) wear away as for the loco wheels. Degreasing and painting these was straightforward and a repeat of the loco front bogie. I could not face however stripping the otherwise satisfactory bogie frames further, so these were degreased again, wire brushed and painted as an assembly: this was obviously done before as the joint surfaces I exposed were bare metal. One improvement I did make was to arrange a tension spring between the brake beams, so that when the air was released, the beams were pulled together. I used a relatively low spring rate here to avoid reducing the brake force too much. The pistons are 0.8" so at 100 psi the brake force is around 50 lbs (23 kgf), low compared to 400 lbs or more when in a car hydraulic application. My reason for this is that if the beams stayed right out with the brake blocks rubbing on the wheels and the cylinder retracted fully, the buttons that engaged with the cylinder ends could separate from them and maybe get out of place for the next brake application: the spring pulls the beams into the cylinder. A refinement I also then had to add was a stop to prevent the beams 'seesawing' around the brake cylinder causing the blocks to rub on the wheels at one side when off. The photo right shows the bottom view of one bogie with the brake arrangement, the 'stop' is as yet unpainted. The photo left shows one finished and reassembled bogie. Interestingly, one wheel on one axle had a taper pin through it like the front loco driver, but by the time I noticed it, I had forgotten whether it was the 'front left' wheel like the loco since the bogies are essentially reversible: the wheel was not loose though in this case.

both bogies, including the lip seals as they came with them (Pre 1967 MGBs had the same size and the MG Owners Club have a very good parts supply!). One of the wheel sets on this second bogie had a back-to-back flange measurement that was too small, so I skimmed 0.02" off each wheel back to make it fit the gauge.

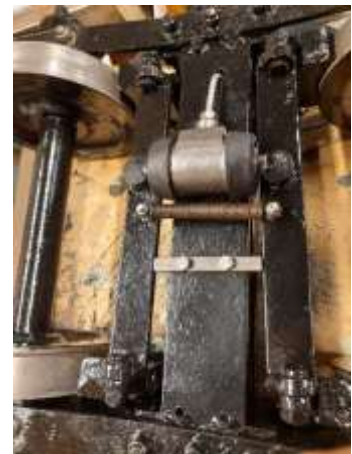
For the record, the axle ends were fitted with roller bearings supplied with grease through nipples, and these were unworn and fine. One of the axlebox covers had a glued in stud/nut that, when I came to replace it, I found the hole in the axlebox had a broken tap in it, so the replacement is cosmetic (stud rivetted to the cover on the inside) and not functional.

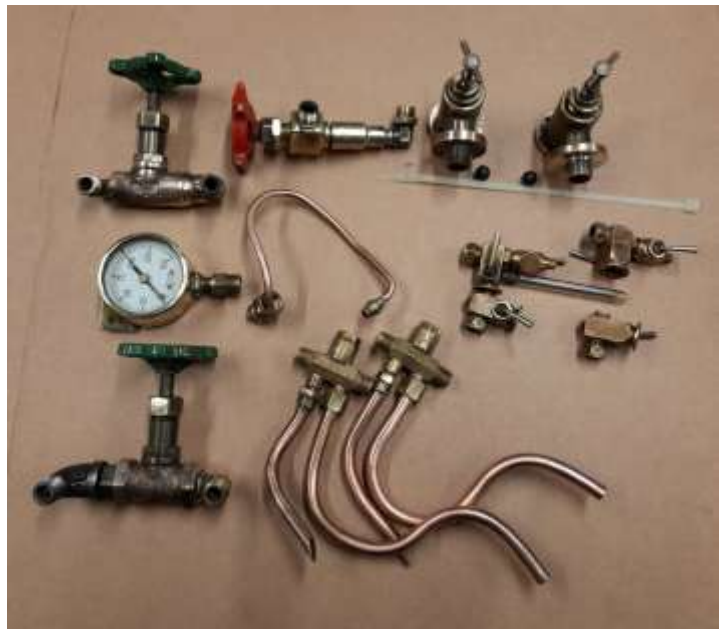
Whilst the tender is off being grit blasted and painted, I started to hunt through the box of miscellaneous boiler fittings. These are brass coloured, however they show no signs of porosity through leaching and so are possibly gunmetal or bronze. I have stripped most of them down (no seized threads!), checked them over and burnished them. Most were painted with heavy black paint that I will not replace. The only repairs/changes I had to make were to replace some of the O ring seals and to replace two 3/8" plastic – nylon probably – balls in the two clacks that mount on the boiler. I found some 316 stainless steel balls for this: I have tried plastic before and they often stuck in the seats much more tenaciously than metal ones. In fact, the clack bodies show many scars each where they have probably been tapped to free the balls! The new balls required the seats to be re-reamed and cut a little deeper, and this meant lengthening the adjustment screws that limit ball lift. The pipes to these clacks have four bolt flanges on them (for looks) but the space to fit the nuts is minute and they are not easy to remove to poke the balls free if the kettle of hot water does not work. I will keep the flanges but probably add a compression fitting on them to allow easy removal for poking. The photo shows the fittings dealt with so far, just the safety valves and whistle to go. The regulator will come (hopefully) with the boiler. Clockwise from top: the two clacks, water gauge fittings (0.29"/7.38mm diameter glass), two injectors (defurred with descalant but not dismantled), centre left is the (tested but uncalibrated/checked) pressure gauge and the rest are various valves for steam control. I imagine I will find one or two items missing when I come to reassemble it all: I am not going to tackle the spaghetti of piping with some connectors and other bits attached until I need to.

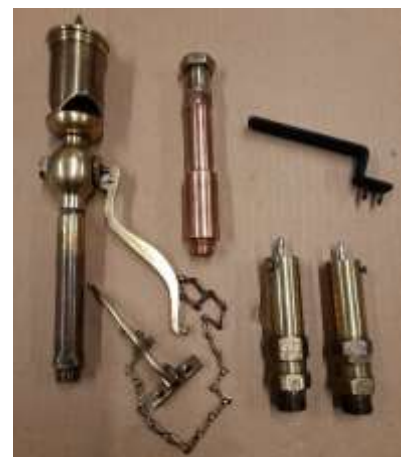
The safety valves seemed fine and I simply stripped and cleaned them. I found a 'valve spanner' in the pile of bits: another item for the box on the chassis front. The whistle is a large shiny three tone 'chime' whistle (at least, it has three chambers) with a sprung valve for the operating chain going to the cab. I had to replace the internal spring (as it was rusty) with a stainless steel one and an 'O' ring. There is one mystery object: this is a largish brass and copper closed end cylinder with a pipe thread on the end. The only thing I can think about (assuming it is part of the loco) is that it is a bung for a boiler hole, maybe to allow initial filling with water for a hose as there doesn't seem to be other arrangements for this in the pile of bits. Or it replaces something for boiler testing (like the whistle) but it doesn't have any removeable bits in spite of appearances to add a pressure connection. This is not conclusive though because initial filling could be via a blowdown valve yet to be supplied with the boiler: I expect I will find out in due course. The photo shows the remaining boiler bits.
