Boilers can Fail

This document was written by Vernon Lidstone and was published in the Southern Federation newsletter in June 2007.

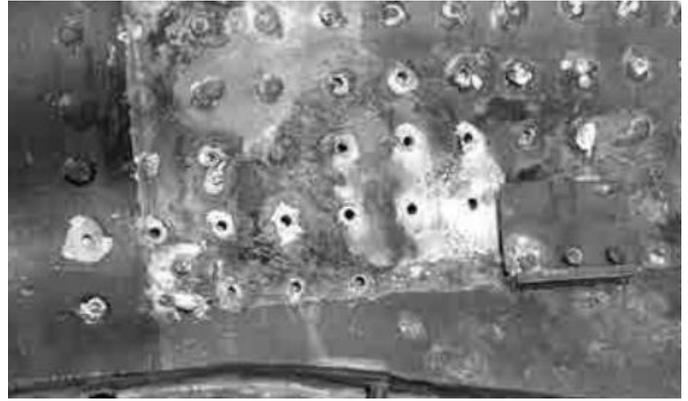
The boiler was removed from the chassis, photographed and taken to Trevor Tremblen, of Swindon Boilers, who examined it. Later the same day two CSME boiler inspectors came and also examined the boiler. They all arrived at the same conclusion that "the silver solder had failed to penetrate the firebox stays". The firebox stays were measured and were 1/8" diameter, in accordance with the drawing, had rivet heads inside the firebox and were at 3/4" centres. Trevor also spotted that the crown of the firebox

had come down about 1/4". You can see from the photo above that a dozen or so firebox stays have pulled out. It has been pointed out that crown stay arrangement is not according to Martin Evan's drawings, which shows a girder stay rather than rod stays. Trevor Tremblen also said that there would be many more crown stays when building a B1 boiler today. All the correct procedures were followed and it is hard to know what could have been done differently, thankfully the boiler failed relatively safely, it did not split

and the cleading deflected the steam effectively, so that fortunately no one was hurt. People have been very supportive despite this serious failure and Swindon Boilers have kindly agreed to build me a new boiler very soon. Many thanks to all involved. Remember, when you are building your next boiler, do pickle your stays and ensure there is enough space for the silver solder to penetrate thoroughly!
