## Mabel a 7 1/4inch Wren Engine

This document was written by Rob Hitchcock and was originally published by Plymouth Miniature Steam and republished by the FMES in the July 2023 Newsletter

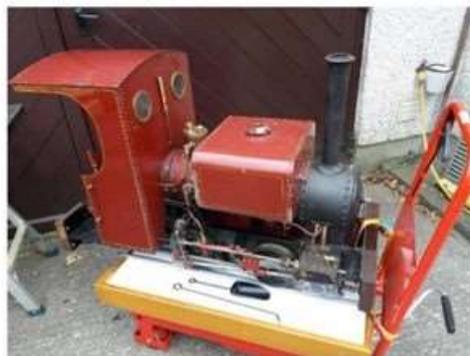
They say that everyone succumbs to a momentary period of insanity in their life, mine occurred in 2022 when I purchased a dilapidated and elderly 7 1/4" Kerr Stuart "Wren" which obviously needed a lot of work. The engine had originally belonged to a public school and was used on their own railway within the grounds, it had some minor rust associated with the platerwork and a water tender which is sat upon to drive the locomotive, it appeared to be minus the internal tank. The tender was not the original and had ride height and suspension issues. The engine was well used although despite its age, the boiler appeared sound apart from a known water leak from the regulator outlet joint in the smokebox. There was a certificate with the boiler, but I would not like to leave myself open to legal action by discussing it. I intend to recertify the boiler before public running such that this issue becomes redundant, hopefully I will not find any other major issues. There was no superheater on this engine although there were two large flues containing restrictor spirals in the boiler to accommodate one, I think this was an option from Swann's original design as I seem to remember "Hernias" first boiler having the same arrangement.

The wheels were several millimetres under the design diameter which although shows some wear would be serviceable but need some attention in the future. It appeared as though the engine has had a mixture of inexpert maintenance together with some good work which had not been finished, for example the boiler is held up by copper brackets on the boiler and should rest on manufactured metal spacers to level the boiler rather than two pieces of firewood wedged in.

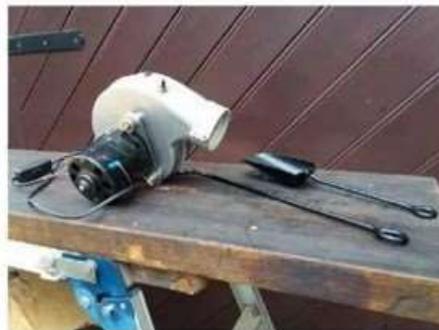
Having wrestled the engine with assistance onto a trailer to bring it home I began to realise that this is not an engine one can manhandle very easily, and having had a slipped disc last year (not related) decided that I had to design and build a handling system to move "Mabel" from home to track etc. this now consists of a rail bridge from my hydraulic lift onto the trailer which will have a set of rails on a board in the trailer bottom so that the engine can be fixed down for transportation. I will also need to modify the trailer with additional lashing points and legs. I have just finished testing a new "Steaming up" blower which I made from kind donations of various bits and pieces namely a metal tumble drier fan casing and a 1960's car heater motor. I also made a coal shovel and poker to suit the firebox hole. (See photos.) I hope to let you have some more detail in part 2. in which I will start to look at the boiler, having already rebuilt the handpump and made new mounting spacers and sourced some stainless plate to make a new ashpan. On purchase I knew there was a water leak around the top steam outlet to the cylinders this may be just a gasket issue caused by a lack of clamping force as the number and size of bolts holding it down appear inadequate, or it could be something more sinister. I have yet to expose and understand the regulator design, which is vastly different to the original, consisting it would appear of a screw down conical valve and seat. I am hoping the regulator "bullet" is not seating on the outside part of the steam outlet in the smokebox as this will put the regulator screw down forces in competition with the bolts holding the outlet, it would then be fairly obvious why the leak is occurring. Anyway, more later when I can make time.
