## Electrical safety and fuses

### ELECTRICAL SAFETY & THE ¼" WHIT FUSE !

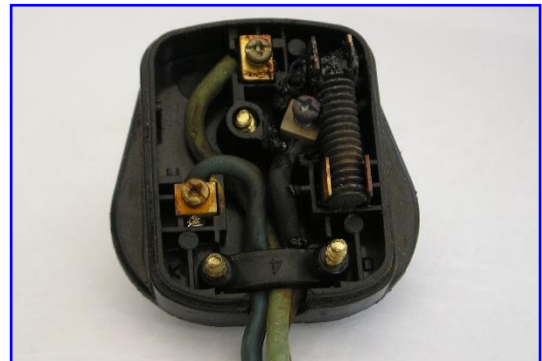
A quick look at the photo below will show the meaning of the heading of this article. It shows that the conventional 13amp fuse has been replaced by a piece of a bolt; it could be M6 or Whitworth, but that is irrelevant.

Examination of the photo will show the burnt area around the fuse carrier, and the obvious overheating in the general area of the fuse retaining clips, the live terminal, and the sheath around the live wire. There was clearly a serious volt drop at this point due to the high resistance joint which resulted in the generation of heat and the softening of the fuse clips.

The other most important point is that you should always check the rating plate of any piece of equipment and, if it is second hand, have it checked out by an experienced person. The rating plate on this piece of equipment was 5.5kW which at 240 volts is 22.92 amps. Simply divide the watts by volts to give you the current. A 1HP motor under no load conditions will draw 3.125 amps. (The start current could be double this in certain load conditions).

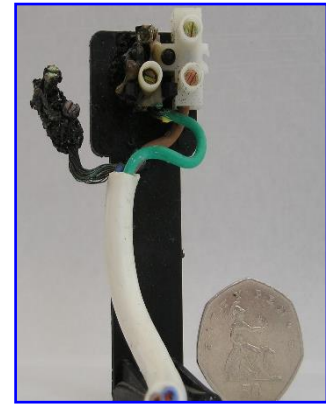
In the second photo you will see another example of overheating caused by loose terminals. This connector block was removed from a 2kW convector heater. The unit was less than 2 years old and was purchased from a DIY store. As with the example described above, this also represented a serious fire risk. The offending unit was installed in my conservatory and the clue to there being a problem was an unusual smell. Many years ago, this problem could often be identified by a smell not unlike that of bad fish on a hot summer's day, with just a hint of bad eggs. The smell with modern synthetic materials is not the same as the bad fish/eggs. The advice is, if you smell something unusual first look in the kitchen and check tonight's dinner, and if all is well, follow your nose and try to trace the smell. By feeling plug tops to see if they are warm can help to identify the source of the problem. If you find a warm plug, have it checked out since there should be no heat generated within the plug top at 13amps.
