“Merchant Navy cladding”

This document was written by Geoff bashall and was originally published by The Worthing Model Engineering Society in summer 2023

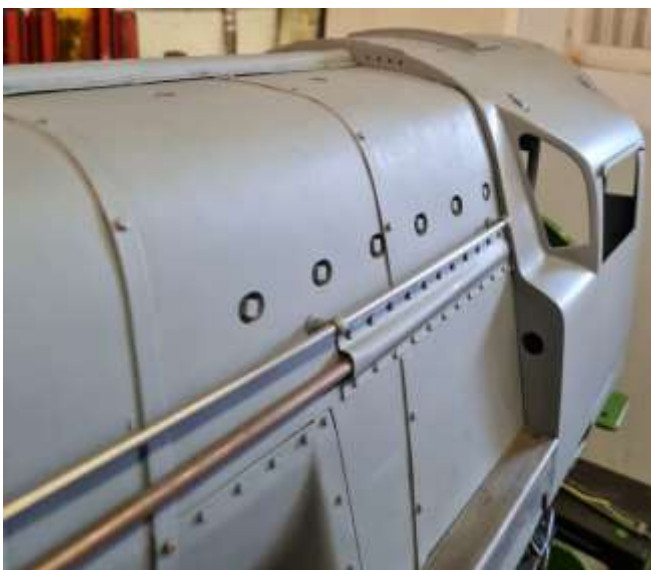
When we build, we do have to accept some compromises with no exception in fitting the cladding. When boilers have overlap joints of 1/8 copper to get the shape, we find that with cladding we have to pack with insulation to try and overcome the problem of shape. Anyway, the cladding is finished and the result is a practical representation of a MN. The boiler dome was a fabrication starting off with a big

piece of cored brass 3 ½ diameter, allowing me to clamp and fly cut to shape to the boiler cleading, with final fettling to fit snug as there is a taper on this part of the cleading, then on to the lathe bore out to fit over bush cover, and then silver solder a piece to fill the cored out section, and finally back to the lathe, a small amount of turning then files, Dremel and sanding to get the shape of the dome cover. Time consuming, as there are no castings available.

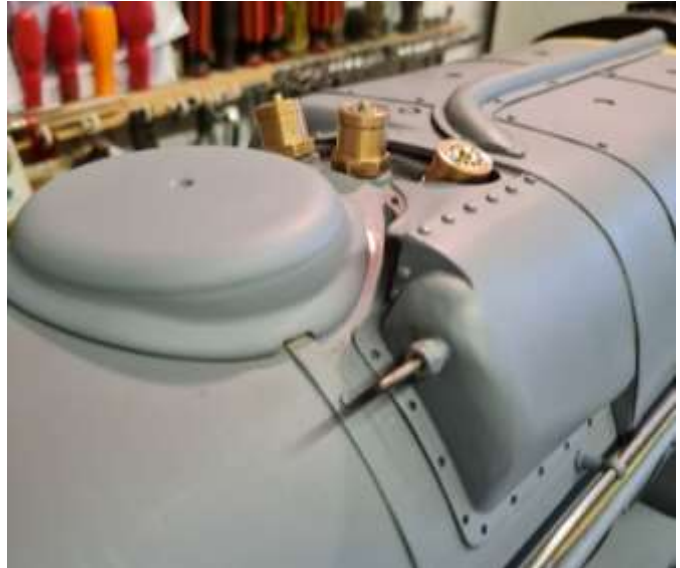
Safety valves were again a compromise to outside shape but with internal dimensions to Gordon Smith design. Our boilers have threads normally ½ by 26. Full size they are bolted down by a series of bolts around the base. I still have to machine the wheel for the dummy control on the left-hand forward shroud.

Widow frames are ready, with 1mm Microscope slides with spares ready in case of breakage, the forward cab windows will be glazed with 2mm Perspex. Now its on to the back head fittings, getting the superheaters bolted in and the hydraulic test to one and a half boiler pressure 150 lbs. As for the chassis, the drain cocks have been changed to standard drain cocks working from a Bowden cable running through a copper tube, the steam operated drain cocks have been jettisoned as most comments about them suggest they can cause problems with clogging up
