“Old Rube restoration part 2”

This document was written by Paul Naylor in early 2025 and is the second article in a restoration project. The articles were published more or less simultaneously in the Frimley and Ascot Locomotive Society newsletter.

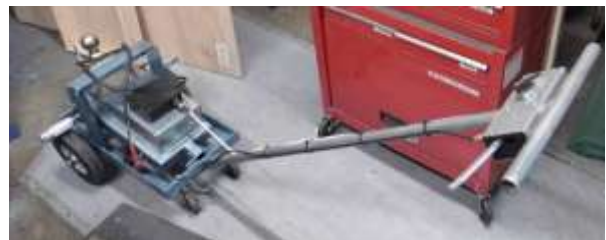
The enormity of it has now sunk in, both to my soul and to my garage floor. Fortunately, it came on its own wheeled trolley (over 3 metres long), and the painful job of removing all of the pipework and a lot of other bits besides (that occupy a number of boxes) has already been done. Painful, because it usually is trying to dismantle something carefully and logically....and if the parts are piled up haphazardly, painful when it comes to working out a). have I got everything, b). what is recoverable and c). working out where in the 3-D jigsaw they all go. The latter set of ‘painfuls’ will be down to me though!

As I get older and find moving heavy things difficult, I have now a policy of putting all such items on wheels... like trolleys for locos and some machines that I don’t use frequently. Now that we no longer have a caravan, the motorised ‘caravan mover’ I made a while ago and that I couldn’t bear to part with will come into its own moving ‘Old Rube’s trolley and loco around!

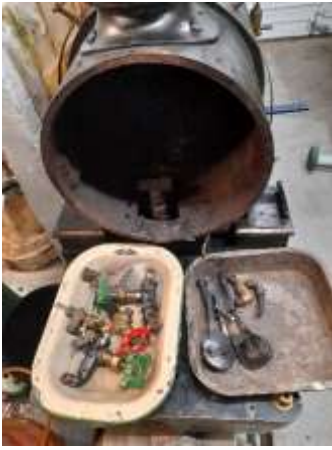
The boiler is integral with the smokebox (that is, the tube plate is recessed about 200mm inside the tube) and I am told this does not allow sufficient room for reliable welding, so it is going to have a separate smokebox. This is probably good news though as it means I can use the old smokebox as long as the company will cut off the old one in the right place. I don't then have to worry about drilling loads of holes in the right place in something 10mm thick and 100kg in weight. As a result, I have started to remove the various fittings still attached. Amazingly, the nice water gauge fittings and the 'robust' but still good condition valves came off easily after much WD40. That cannot be said for the bolts holding bits to the smokebox like the chimney and other brackets, some sheared and I will be cutting off others.

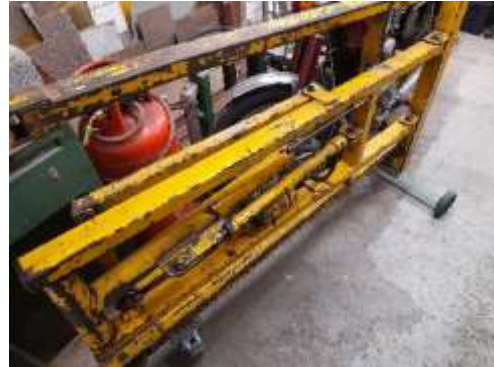
The only other progress for this article is the ancilliary item I got with the engine...a 1980's 'engine' crane (yes, I know it is obvious, but engine here means car engine). Whilst this seems to work OK if a little scabby in appearance, it weighs a lot and the wheels on it, being cast iron and small, do not allow easy movement. In addition, I want to store it on its side and so I have welded up more wheels (larger and with rubber tyres) to stick out sideways when being stored. I am pleased to say that this works fine and I can trundle this around easily now.
