“Old Rube restoration part 6”

This document was written by Paul Naylor in summer 2025 and is the sixth article in a restoration project. The articles were published more or less simultaneously in the Frimley and Ascot Locomotive Society newsletter.

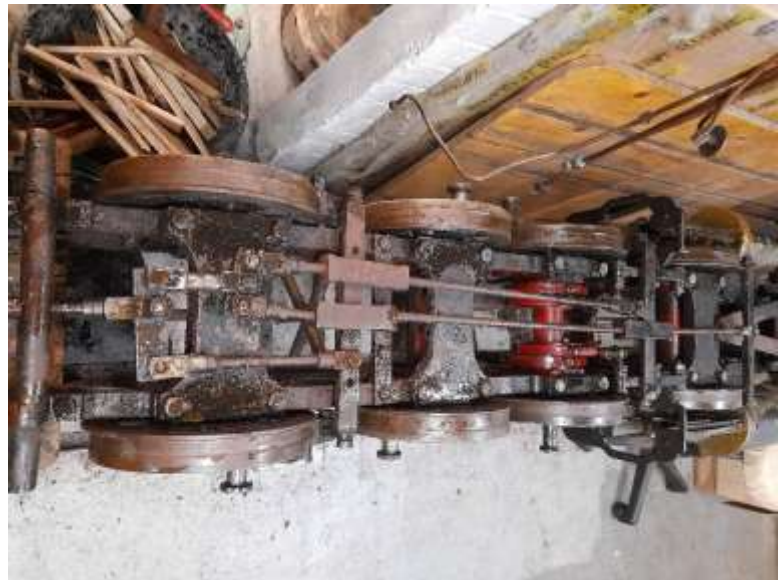
Some of the work needs me to obtain more labour to help move things, and this is usually limited to family visits(!): my son came the other day and we were able to invert the chassis so I could get at the brake linkage (to remove it) and the wheel axlebox keeps. This is what it looks like after the

oily and grunting: note the somewhat agricultural but fully compensated brake linkage that I hope to remove now in one piece for now to retain the relative positions and avoid having to remember it all (for now).

Well, amazingly and in spite of looks, the brake linkage came off in one piece by removing the brake hanger nuts and the adjuster nut at the rear. There was enough slack in 'the system' to remove it without issue then. At least I don't yet have to worry about which bit goes where, although it needs cleaning, painting etc and that will need a strip down. The next

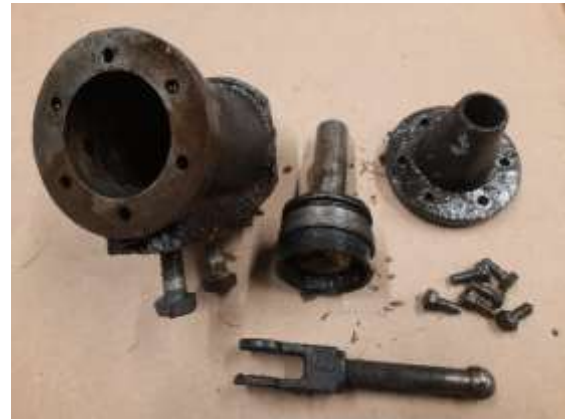
Next for now on to the brake cylinders. These are substantial castings, one on each side, operating the loco brakes using compressed air. Although externally they look 'ropey', the fact that they run on air means that internal oil and grease is retained and the insides were very good. Even the rubber cup washers and cast iron piston rings are in good order and will live again. The only casualty is one of the cover securing bolts on one cylinder which simply turned in the hole thanks to stripped threads, so I need to find a way round this when I re-assemble. The photo shows the simple design and appearance prior to cleaning.

Cleaning and repainting was easy, involving – after degreasing - a few minutes under the wire wheel mounted in my second double ended grinder. I

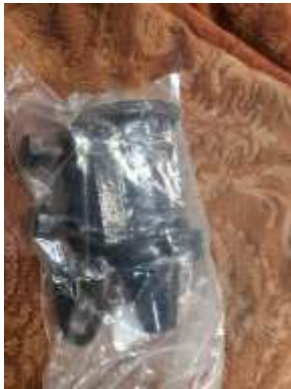
other. I decided to use satin finish 'Rustoleum Combi-colour' paint for this (and for the future chassis jobs too) as my experience is that it goes on well with few runs, dries quickly and doesn't need primer... and lasts. They were then reassembled with new grease and the stripped thread it turned out was owing to an over short bolt that depended on a few threads that had pulled out: there was enough material to deepen the thread and recut it and use a longer bolt. This cover is not subject to full air pressure as it is on the 'open' end of the cylinder and the cover simply supports the piston rod. I have been 'bagging up' finished bits to keep them together and safe! On the subject of threads, I am still trying to make up my mind whether imperial or metric is the ruling standard here: the bolts seem to be

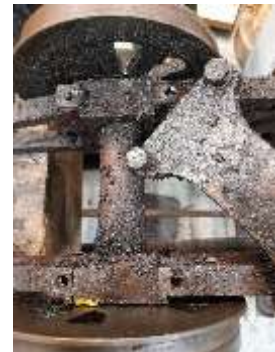
With all the brake gear removed, I was able to see if the keeps would come off easily: the oil present ensured they came off fine and I could see that I will then be able to lift out the wheel sets on three of the axles with no issues: the fourth is the driven axle and has the eccentrics and valve gear attached, so that is a little harder but other than using allen keys in confined spaces (ie 'one flat at a time'!) will not difficult to remove the straps. I have not yet completely removed these as I will need to mark them to replace them in the right places: the eccentrics themselves will stay on the axles during tread returning as I do not want to disturb the wheel quartering to get them off. The same will be true of the axle boxes
