## “Old Rube restoration part 15”

This document was written by Paul Naylor in winter 2025/26 and is the eighth article in a restoration project. The articles were published more or less simultaneously in the Frimley and Ascot Locomotive Society newsletter.

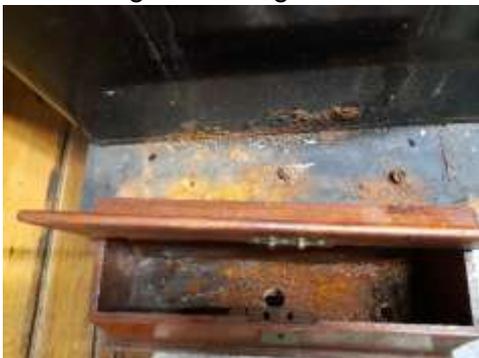
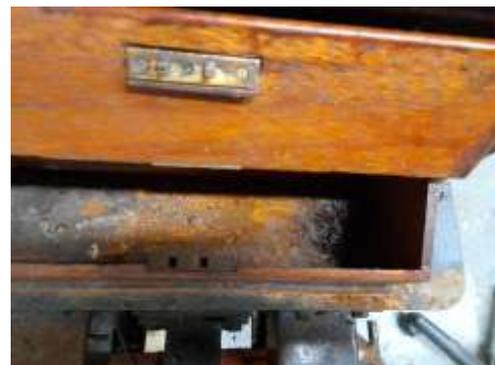
On the buffer beam at the rear is a nice mahogany lockable (no key though!) box. I thought that this would be an easy to remove piece to refurbish and looked to see how it was held on. Three bolts and nuts did the job, and one had already been removed. The other two are *really* rusty and seized and the bolts are about 30mm longer and rusty (underneath) than they needed to be. Getting something to the somewhat inaccessible nuts

is very hard, so I decided to use a small hole saw that just fitted round the bolt heads and cut

out a circle of box bottom round each to get it out. As you can see from the photo, this increased the refurbishment necessary! I will need to sand it all down, mend the holes I made and revarnish it. I probably won't make a new key (it is a standard bureau top type lock that are simple to make with

a little experimenting) as it is not really necessary and will be first to get lost again. I will cut the bolts with a cutting disc when I come to ‘do’ the tender. Sanding it got rid of many dents and other marks and a coat of standard oil-based satin varnish to seal it (that took ages to dry), followed by more rubbing down and two coats of fine gloss varnish to make it attractive.

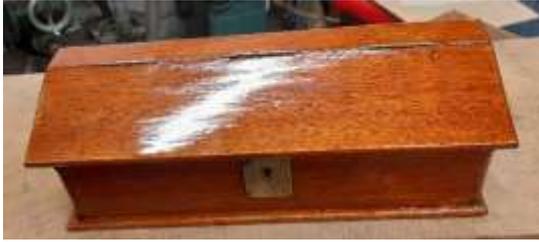
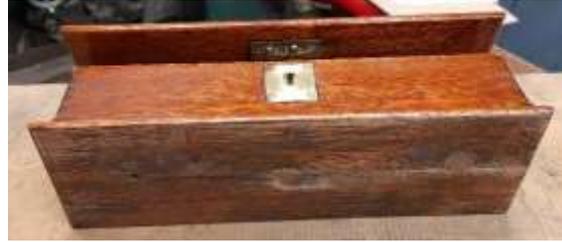
Duly finished, with wood plugs filling up the holes in the bottom... set it aside for later fitting, using the

same holes as before: I will drill these in the new wood on reassembly, maybe only two though.

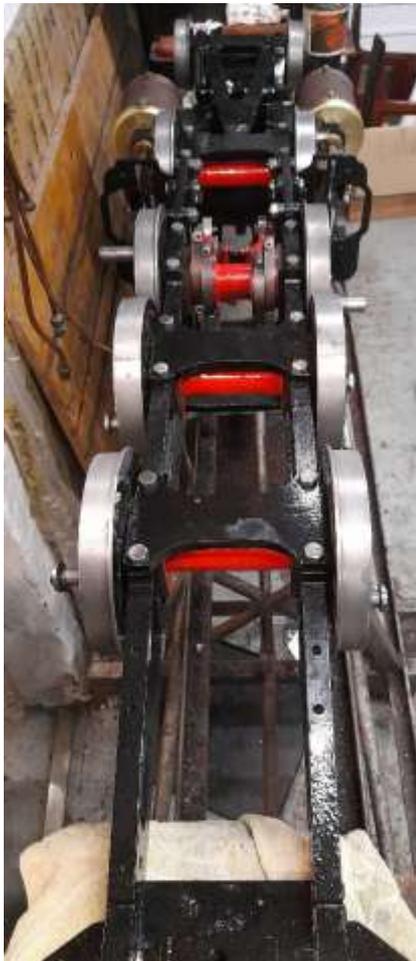
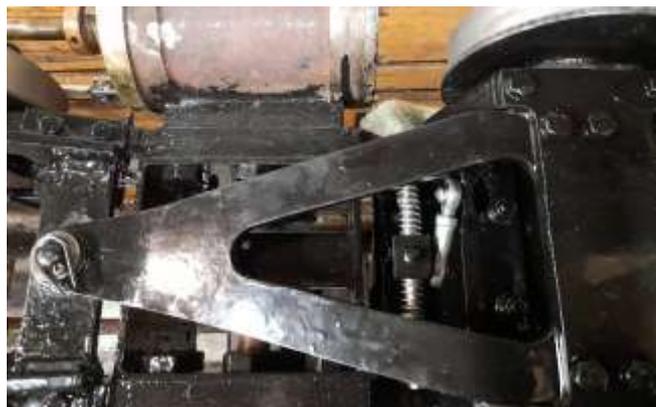
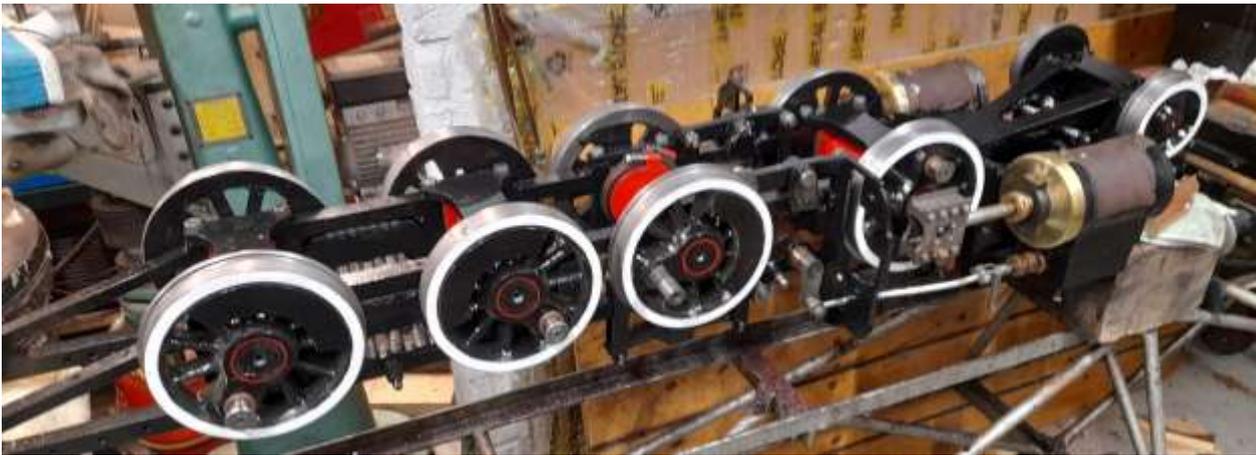
Starting with the rear axle and progressing to the front, it all went well. I greased all fittings as I replaced them, and used copper grease on bolts that I don't want to seize in the holes (again). Here and there I added stainless steel washers to protect paintwork, especially on some bolts that had to retain some movement, such as those securing the spring hangers in place. New split pins were used where required, and I made sure that everything moved freely as I went. After a couple of days of reassembly, I had an upside-down chassis with the springs, hangers and wheels in place, the eccentric sheaves refitted and the bogie fitted along with its new side control. On this last item, the bolt fixing the rose joint to the bogie frame was a right \*\*\*\*\* to fit as I did not have a long Allen wrench and had to fiddle the bolt home a flat at a time before the Loctite 270 I used to stop it coming

loose went off. The result can be seen in the photos, including the side control arrangement now installed. The side

control springs return the bogie to centre line if pushed over, and the resistance (ie the force

assisting the curve) seems about right by feel. I remembered to polish up the rear cylinder covers before fitting the front wheel set while I could get at them all round.

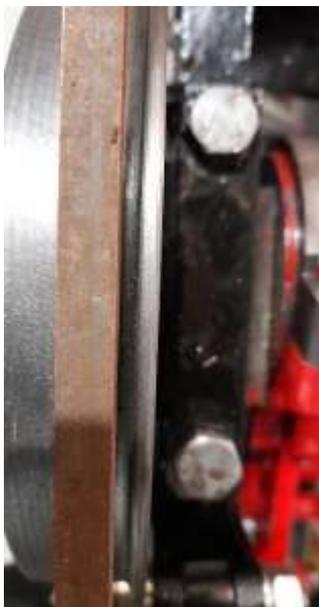
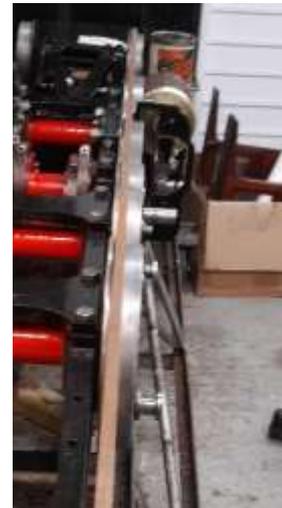
Now that the wheels are in place, I can measure up the gauge allowances for going round bends. Needless to say, the actual slack in each axle sideways movement is not as much as the addition of measurements would suggest, possibly owing to paint thicknesses etc that will wear through in use and 'bed in'. The actual situation is that the first and fourth axles have around 1mm of allowance sideways. The third does not matter as it is flangeless, leaving the driving axle. I used a straight length of square section steel (however with sharp corners) placed 'naturally' against the root of the flanges of the first and the fourth wheel sets when pushed to the right (chassis upside-down) as far as they comfortably want to go, and then pushed the driving axle over to the left. Placing the 'rail' so it sat up to the flange (actually the root of flange radius), I could then measure the allowance at the driving axle. The photo is a little hard to see owing to the camera depth of field

required but it shows the method. The second photo shows the gap between 'rail' and flange at the driving wheel: it is around 2.5mm. To complete the picture at least for the loco, the flange root to flange root on all flanged wheel sets is 182mm (7.16"), so the total allowance on a rail of 7.25" gauge is a further 2mm - since this is *all* wheelsets, I can double it for this calculation (I am using the formula I presented in article 9 for this). This means that without gauge widening on the track itself round curves, the loco will go round curves down to 20m – unfortunately not quite as low as the 18m of the track 'at base'. Given I do not want to thin the flanges more, and there is nothing I can do about the sideways movement, I need around 0.5mm gauge widening on an 18m curve to go round easily. I suspect that the track has this amount of wear at present, let

alone deliberate widening, so I live in hope. I have some 'back pocket' allowances too that I have not included:
