## “Old Rube restoration part 19”

This document was written by Paul Naylor in spring 2026 and is the eighteenth article in a restoration project. The articles were published more or less simultaneously in the Frimley and Ascot Locomotive Society newsletter.

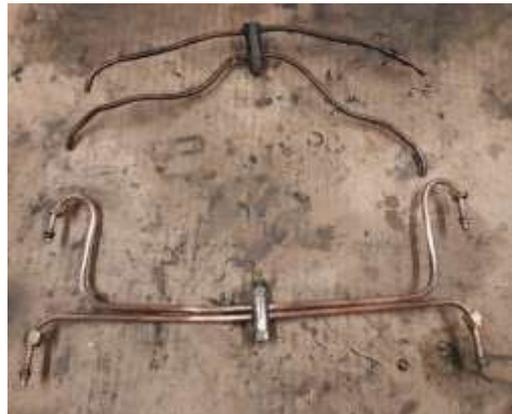
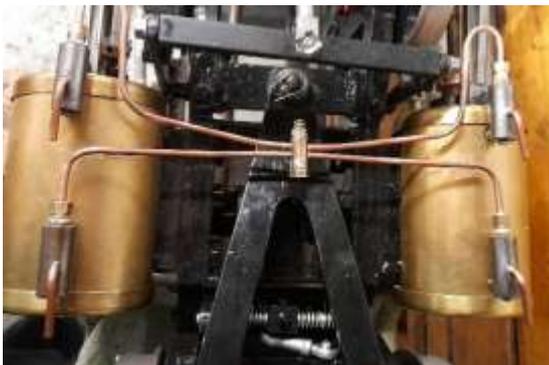
Thinking about the prospects for re-inversion of the chassis, I thought I had better make sure that the drain cocks fitted OK and the plumbing was serviceable since accessing this when he right way up would be difficult. The drain cocks themselves are OK (now) and they screw into the cylinders without fuss. I made some PTFE washers to fit in the hole before the cocks were screwed in so they could tighten up to something resistant, without this they would have been either free to rotate or not lined up neatly. Then I thought I would see if the pipework I had would be usable. Yes well, it shows many signs of bending and re-straightening, and the pipes were kinked here and there. I decided to remake this, and try to get it slightly higher in the chassis to protect it more. I retrieved the pipe cones and fittings from the drain cock ends to use again, and similarly used half of the central manifold so I did not have to remake any union nuts. The photo right shows the cannibalised old pipework and the new one below.

I then thought I might as well fix it in place: if it is in the way when turning the chassis, I can easily remove it. The pipe from the central manifold is amongst the pipework I have and I have no idea which: I may

remake it from this union to another more accessible on the top of the chassis anyway for future ease of maintenance. That completes the work on the chassis prior to turning it over, which is a job that will have to wait for family muscle to come and help. In the meantime, I have been reviewing activities on the tender...

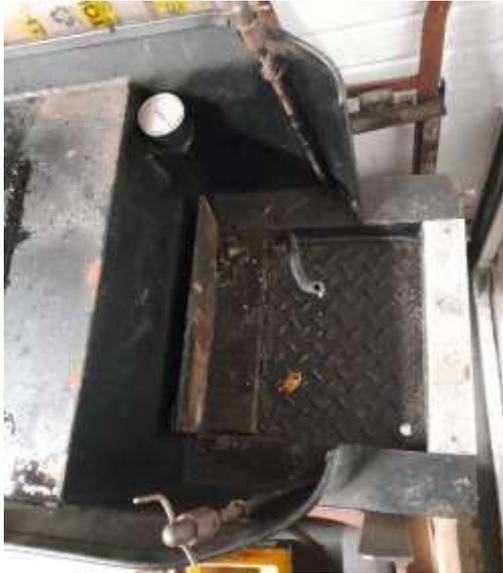
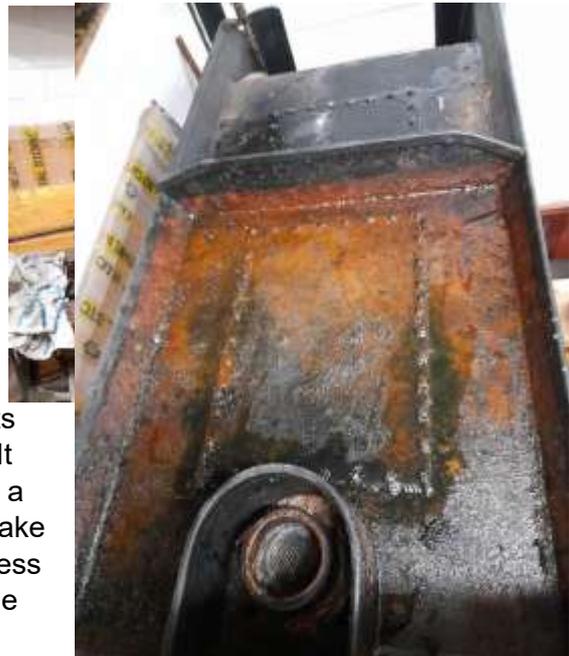
As a reminder, this is a large rectangular steel fabrication welded up with the chassis rails and the bits and pieces (like bogies etc) bolt to it. I was using it as a wagon to hold bits, but I have now removed these to get over the 'what have I got to do now' demotivation (!). Most of the work will have to be with it upside down (on the floor more than likely) and I shall ready it so my visiting muscle can help with this too. Hopefully it will not be too heavy for me to shift

once the bogies and some other bits are removed. It does not have a tender handbrake so that's one less complexity. The main initial

activity is to remove the two access hatches on the top to investigate the internals. It is painted but otherwise untreated steel, so I am hoping that I do not have let new steel into it anywhere owing to rust. These hatches (that I may replace with trays to hold things like a compressor, battery etc) are secured with a million bolts it appears (why?): I am hoping that the spilled steam oil all over the top has kept them rust free, which would be one

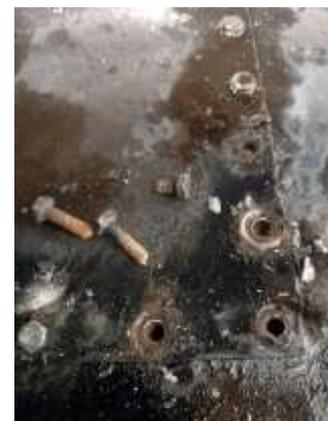
Well, I had a go at removing the bolts around the hatches after spraying WD40 around and leaving it for a day. After trying different spanners, I eventually discovered they were 2BA hex head bolts ... and they were seized in. The first couple I tried (in the forward hatch where they did not look as rusty) sheared off in spite of taking care to avoid this. Then I heated a few of them up to nearly red heat and tried again. One came out OK, revealing it was an inch long, the next

stripped the threads but came out in the end, the next came a couple of turns out then sheared off. Obviously then bolts might well move but the long portion of thread inside the tank is rusty and stops many of them coming out. The other snag is the amount of oil around the tank top providing an extra hazard using heat! At least a probe through one of the holes shows that there are no stiffening beams around the hatch edge for longer threads than the 2 or 3mm the tank is made of.

What to do next? It is going to be essential to get these hatches off to see inside let alone any improvements. My current thought is that since I am going to modify them anyway, I could just use an angle grinder cutting disc to cut them out round the hatch edges (taking out the bolts, hatches and tank surround with the defunct holes in). I don't want to do this in the workshop and spray metal and disc dusk everywhere, so that will have to wait until it is stripped more and more easily moveable. I always used to say that my definition of an acceptable work space is where you could angle grind a water tank and not annoy the neighbours... about to be put to the test. Memo for later: refit hatches with fewer screws (if not some sort of quick release catch) and use stainless steel fixings.

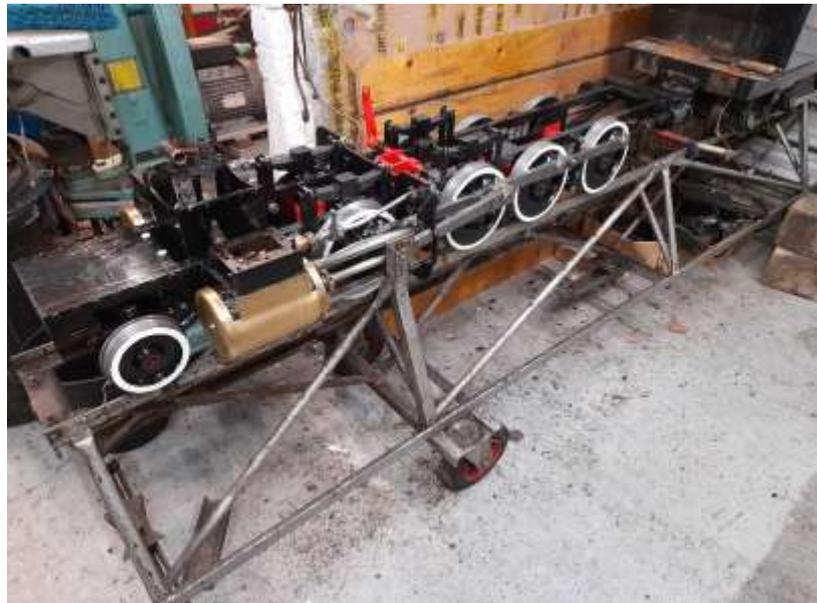
I was getting a little impatient waiting for family muscle to visit (he is moving house, so I suppose it is understandable!) and so I decided to tackle it myself. The chassis needs to be inverted and turned, as it is the wrong way round as well as upside-down. I attached two slings to front and rear, lifted it off the stand and lowered it onto blocks on the floor. I then removed the front sling and lifted the rear end upwards until it was vertical, by then the front buffer beam was resting on many towels on the floor. The bit the wife did not like came next: holding the chassis vertical while I removed the rear strap as well and replaced it on the other side. This meant that I could tip the chassis past balancing point and let it down to the floor again, this time the right way up AND right was round. Reattaching both straps allowed me to lift it again, this time to put it back on the rails. In the end, easy and used more adrenaline than physical effort. This is where I no doubt remember what I had forgotten to do while it was upside-down... but at least it is on all 'fours' and I can carry on with topside work.
