## “Old Rube restoration part 23”

This document was written by Paul Naylor in summer 2026 and is the twenty third article in a restoration project. The articles were published more or less simultaneously in the Frimley and Ascot Locomotive Society newsletter.

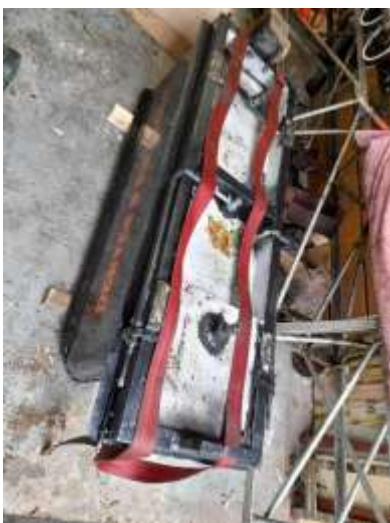
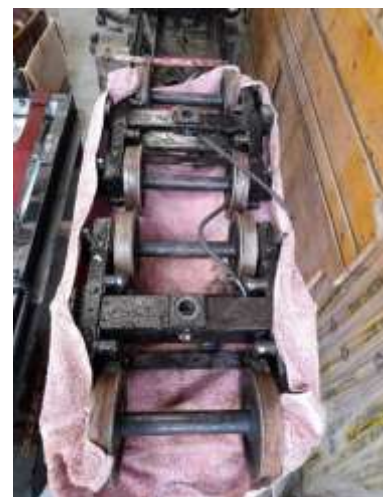
Taking the bogies off significantly lightened it to the extent that I could lift each end off the ground myself. I then strung it back on to the crane and, while suspended, treated it to a spray with degreaser and a pressure wash – and the same for the bogies. This got off a lot of the sticky old steam oil on the top, but I had to do more applications of degreaser wire brushed in and washed off before it started to look clean. After this lot I was soaked through (there are a lot of angles on a tender that when you spray into them it all comes straight back at you, like radar reflectors on ships!), so it was time to put it all away and let it – and me - dry. It was a lot easier now that it was lighter, and it is now on the floor upside down waiting for me to strip (and check) the underside components (the red strip is my now soaked lifting strap drying off as well). On a superficial glance, more good news is that the

tender wheels look OK and not really worn, and for some reason the underside of the body was not painted black.

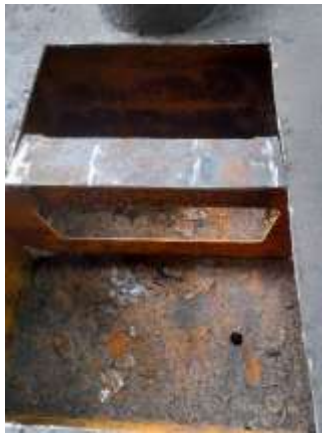
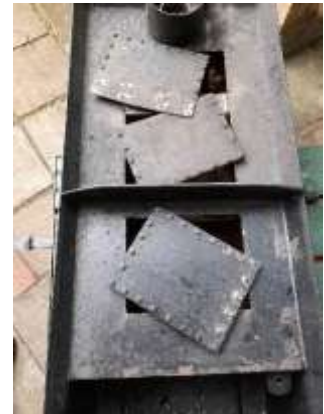
After walking past (round!) the tender body for a couple of weeks, I thought I had better get on with it... I was not looking forward to dealing with the rusted-on covers. A spur for this was visiting a local grit blasting and powder coating specialist to get a price and in order for them to do this, they needed dimensions, so I manoeuvred it to a suitable place outside for photos. Then I thought no time like the present, so got the angle grinder out to cut the 'hatches' out. After wearing away four 1mm cutting discs, I was able to see inside the tank, presumably the first eyes to do this for 40

odd years. Since there was a brace across the larger hatch, this complicated the cutting out a bit and it ended up in more than one piece. After these photos, I cut away the cross bit of the brace away too, although this was a little messy owing to poor access. I

cannot see any evidence of coating on the steel inside and it was quite rusty: this is what 40 years of wetting/drying a bare steel surface does. I got the scrapers out to get the flaky rust off so that I could see the condition of the steel underneath (hoping not to find very thin remaining sheet and/or holes). There were three shovelfuls of flakes after this, but no holes or dubious looking plate. I imagine that it is thinned in places of

course, but since it started out 1/8" thick, I think there is sufficient left for the purpose. Whether the grit blasters leave any steel of course is going to be a moot point.

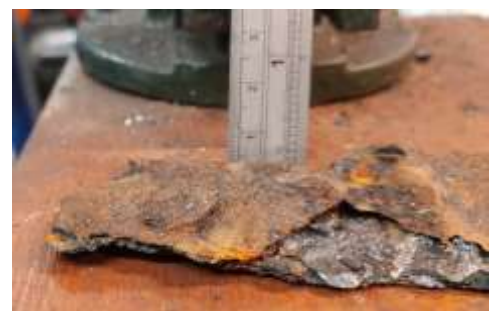
As an aside, I took a photo of the thickest bit of flake (about 25 square cms) - it is nearly 5mm thick. When steel oxidises (rusts), the resulting compound is a mixture of the original iron, plus an assortment of elements from the environment making compounds mainly like hydrated iron oxides. The chemical formula for these is similar to  $\text{Fe}_2\text{O}_3 \cdot n\text{H}_2\text{O}$ , where  $n$  might be greater than 1. In crude terms, this means that for every two iron (Fe) atoms, there are at least four Oxygen (O). Ignoring the hydrogen (H) because it is very light, this in turn means that for every original iron only atom, atomic weight 56, there are at least another two oxygen atoms, atomic weight each 16 – so rust weighs at least 57% more than the iron did that it came from, and it takes up more space. This means that the tender weighs more now than it did when it was new, and the volume is more, hence the flaking causing deflection and disturbance. For those with experience of rusting older cars, this will not be a surprise!

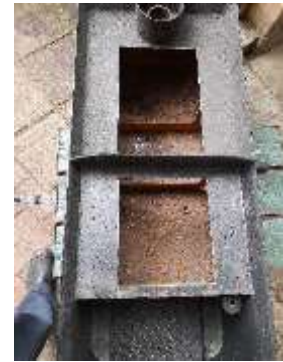
I also cut out a larger hole for the front hatch: I intend to make two more 'hatches' to cover these holes, but as boxes let into the tender top. The larger rear one will be about 80mm deep to house things like a 12volt battery and compressor, and the front one to hold coal. I will also make them easier to remove to check the insides from time to time. There will be a loss of water space as a result: I did try to work out how much loss this would be in terms of running time between refills, and it came out as a reduction from around 10 laps of my club track (c10km) to around 8 laps so not really significant. This alteration means some metal bashing and welding 2 or 3mm thick steel (the tender seems to be 3mm/1/8") as the next major job before it goes off for grit blasting and powder coating (inside and out). I looked through my stock of sheet and found some 3mm... and it was exactly the right width for the hatch widths! That saved some time and a couple of cutting discs. In case you wonder where this sort of 'stock' comes from, I had a habit a good few years ago, of raiding (with permission of course) the skips of an engineering company I worked for and also from time to time, paying them scrap rates for odd bits of steel that I thought might come useful one day. Other projects have not required the use of 3mm steel in any quantity, so I still had it...

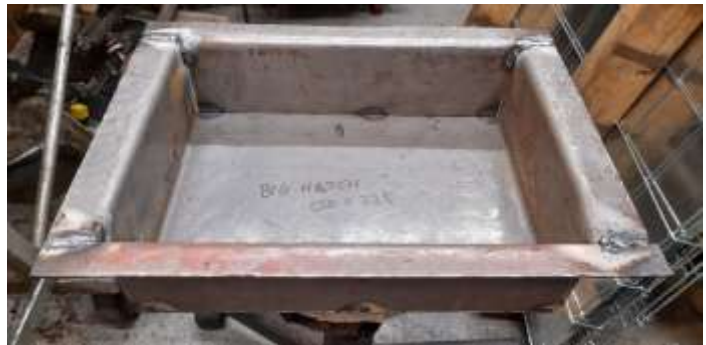
I don't have a bending machine, and all the ones at companies I used to know around me have gone, so out with the heavy hammers. I started with the large (and rectangular) cover, making it in three pieces: a long bit for the length, two ends and flanges, and then two side pieces with a flange on each. This way, all the bends are relatively easy to make by hand and I don't have lots of cutting and welding that more flat pieces would need. I marked out and cut the sheet with the angle grinder, and bent the pieces up as best as I could with the aid of some heavy steel bar G clamped to the plate and then bashed as evenly as I could with a large hammer until the folds were at 90 degrees. Inevitably, there is a large corner radius this way that more bashing can reduce. Not as neat as a large folder would do the job but sufficient, I hope. Actually, the hardest part of this is putting up with the noise (wear ear defenders!), then the complaints afterwards (wear ear defenders here too... but choose times sympathetically). After checking and fettling the bits to fit each other, and grinding some weld preparation into the plate, I tacked the bits together. For this gauge, I tend to use my MMA stick welder, although I will only attempt welds on the outside edges, leaving those inside clean. The point of these covers is that they are for holding stuff rather than adding essential strength, so as long as the welds are sound (and stop water entry from the tender when it is full), they will suffice. The photo shows the results after tacking. The numbers visible refer to the size of the main plate before bending.

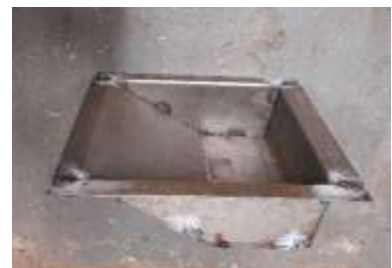
This is now done and I can put the ear defenders away for a bit. This cover is a little smaller, but it does have the complication of a sloping bottom to make it easier to scoop coal. I have checked that they both approximately fit their respective holes in the tender.

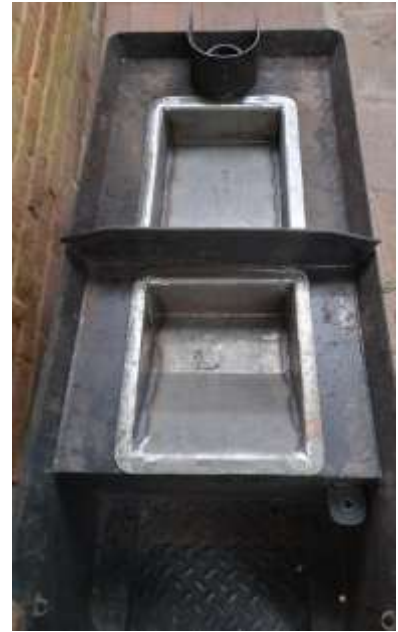
Welding completed, ground smooth and holes tidied up in the tender top now, the photo shows them in place, I need to think about holding them in next. Since they (and the tender) will be powder coated, I also need to arrange the means to hold them down, and also any bits and pieces for the contents of the rear box, intended to hold a battery, air compressor and no doubt a relay and wiring. The rear box in particular is likely at some point to get flooded with water (note proximity to the tank filler) and so I need to include a drain of some sort since turning the tender upside down in operation is not an option.

The contents of the rear box will be protected with a wooden cover including a tandem seat in due course.
